**Statement of Need supporting document
St Stephen's Church, Shepherd Bush
Follow-up report in relation to condition of slate covered roofs**

11 December 2019
6093.02

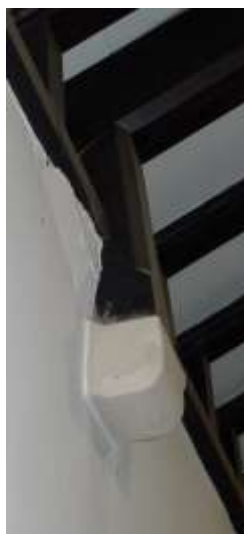
South Aisle

Further to my inspection in December 2015, I arranged for sections of the roof covering to be opened-up to enable the cause of repeated roof covering failures to be investigated in closer detail. I also arranged for an inspection of the roof structures by a conservation accredited structural engineer, Alan Baxter Limited, as it was clear from my last three visits that the aisle structures in particular were suffering outward movement (or rotation) and that while the original displacement of timbers may have historic origins, something is still actively causing ongoing movement. A copy of the engineer's report is appended.

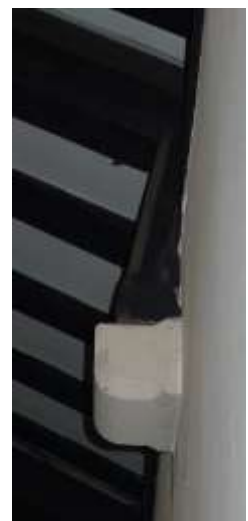
North Aisle

A section of scaffold was erected at the east end of the north aisle with a bridging section spanning the chapel mono-pitch roof and abutting the northwest eaves of the chancel roof. Sections of slate coverings were lifted on both roofs – see photographs of typical conditions.

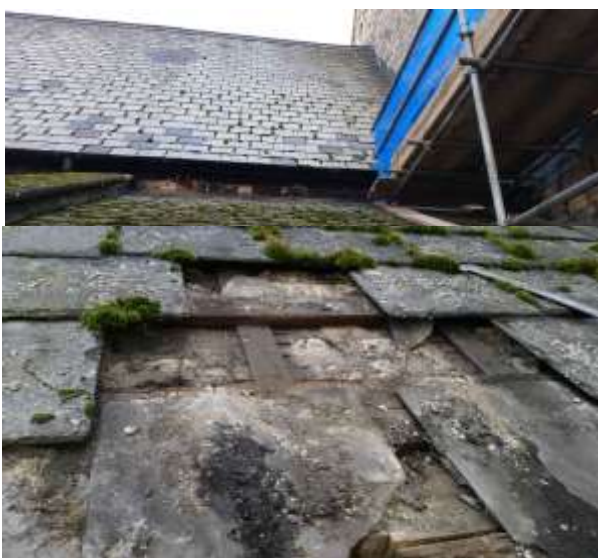
The slates are mostly Welsh but with large scale and many small-scale replacements from numerous other slate sources, including Spanish. The original slates are 22"x11" (560mmx280mm) and of good thickness with little delamination but several had the holes punched very close to the edges (10mm typically) making them prone to failure. The later replacement slates are generally of much inferior quality with delamination already apparent.

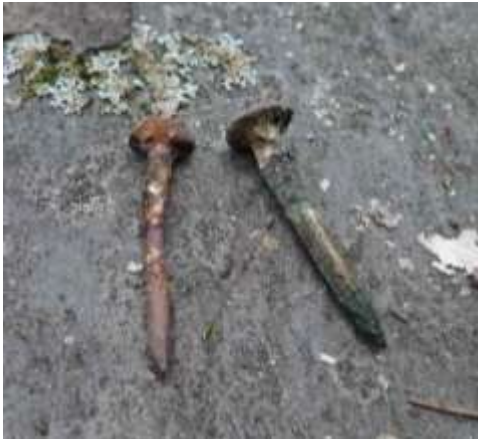
The fixings of the slates comprise both copper and steel shank nails 32mm long. There was no discernible pattern to where the copper and steel nails were used but all of the steel nails found were severely corroded – see photograph. It seems highly likely that there will be extensive nail corrosion across these roofs and that this is a primary cause of the failures noted.

In summary, the Church have done well keeping the coverings broadly intact but for a number of years but I strongly recommend that all the slate roof coverings be stripped and re-covered within the next 12 months if possible but certainly during following year at the latest if the risk of significant ingress and potential consequential damage is to be minimised.

The re-covering will necessitate new battens, counter-battens, lead flashings, soakers and valley linings and consideration should also be given to improving the thermal insulation to these areas. The proportion of possible re-use of slate is estimated to be no greater than 30% and possibly rather less.

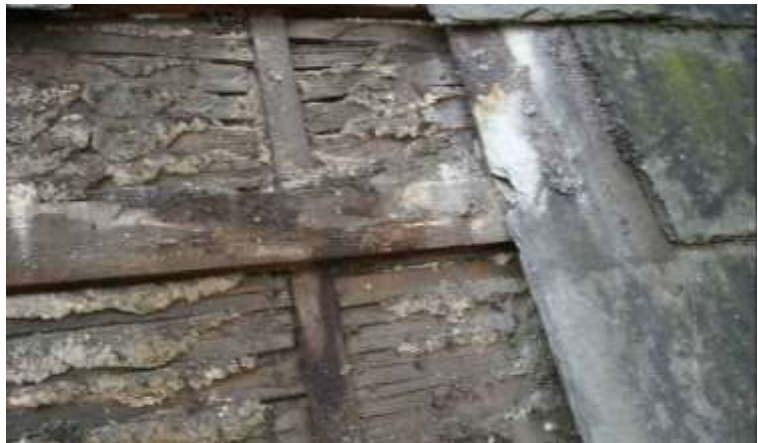
Brief inspections of the remaining church roofs were carried out using ladder access and it is believed that similar conditions are likely to both faces of the nave, both faces of the chancel, the north aisle, the north porch, the chapel mono-pitch roof and the double pitched vestry roofs on the south side of the chancel. It is interesting to note that the south aisle, which was in a noticeably better condition, has in fact been re-covered in second-hand slate laid on 19x38mm battens over a type 1F felt underlay and counter-battens. Defects to this latter roof are generally limited to impact damage from falls of slate from the nave roof above it although the condition of the flashings is now worse than at my last inspection.

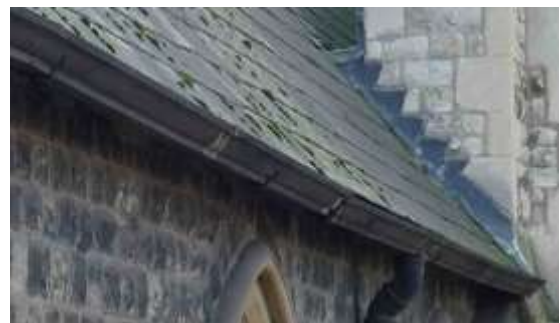
The rainwater goods are mostly of cast iron but also some uPVC. Whilst of adequate capacity, they are in poor condition throughout with extensive corrosion evident to iron sections. Many sections will need to be renewed but when each section is dismantled, I suggest that the individual components be examined to see whether it is feasible to have them shot-blasted and refurbished rather than renewed. Alternatively, it may be possible to seek permission for the installation to be changed to powder-coated aluminium.

The further structural investigation and repair of the aisle roofs will need to be carried out in conjunction with the re-roofing work and the above-ground rainwater installations should also be renewed or refurbished throughout. It is not yet clear whether any salvage of rainwater installations will be realistic but at this stage I would assume not.
