October 8, 2018

Champlain Towers South
8777 Collins Avenue
Surfside, FL 33154

**Re: Champlain Towers South Condominium
Structural Field Survey Report
MC Job# 18217**

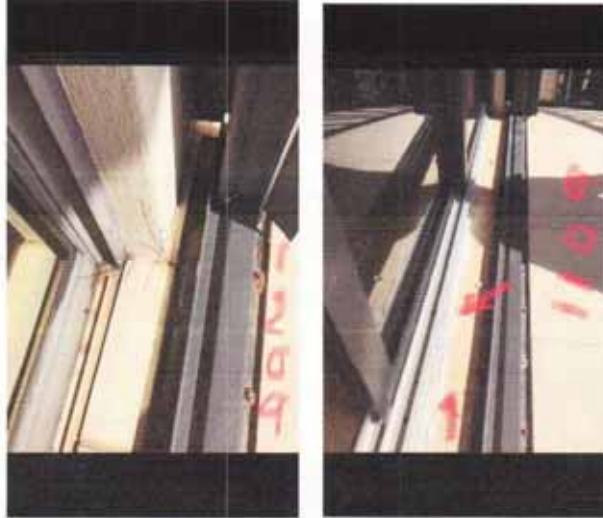
- A. MC understands some unit owners have complained of flooding into the interior space of their unit during a hurricane event. MC has concluded that this infiltration is occurring through the balcony sliding glass doors & windows due to the lack of proper flashing at the sill of these doors & windows and deteriorated exterior perimeter sealant between the window/door frames and masonry/concrete walls. MC recommends that the exterior sealant be removed / replaced at the sliding glass door & window perimeter to assist in providing a water-tight condition. Unfortunately, the new sliding doors in unit 209 and above were not installed properly and were fabricated too tall to allow the base flashing to be properly installed, so these unit owners have no choice but to discard the newly purchased doors and have them completely refabricated.

Figure A1: Exterior sealant past its serviceable lifespan at sealant between the window/door frames and masonry/concrete walls & balcony floors

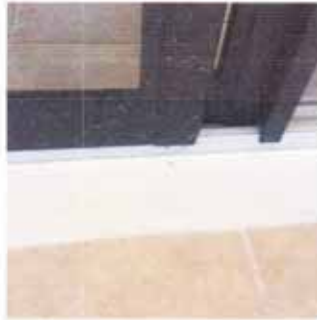
Figure A2: Newly installed sliding door at unit 209 that was not properly flashed

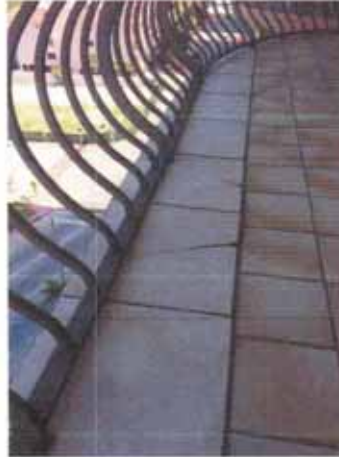
- B. MC observed that the majority of the balconies were furnished with tile or some other floor covering by choice of the tenant, making it impossible to observe the condition of the topside of the balcony slabs. Several instances were noted where balcony tile was damaged, such as in Unit 1008. Based on MC experience, cracked tile usually means structural damage exists to the balcony slab that must be repaired per the requirements of the International Concrete Repair Institute (ICRI) prior to the installation of a pedestrian waterproofing membrane.

Figure B: Damaged balcony tile that must be removed to fix structural damage

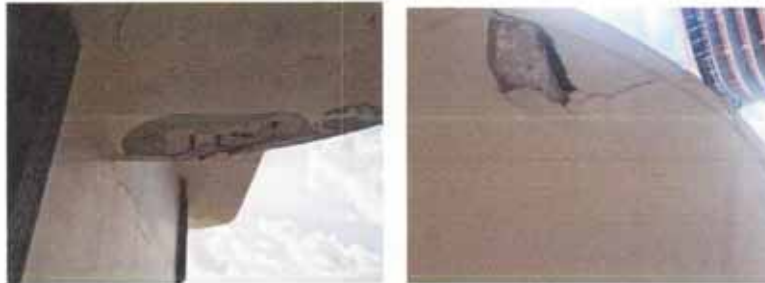
- C. MC found it fairly typical that the concrete slab edges of the balconies are experiencing concrete spalling or cracking. MC sees this as a common source of water infiltration and a main cause of the commonly found, sub-surface deterioration at the exterior soffits under the railings. MC requires that the balcony slab edges be further investigated and repaired in accordance with the recommendations of the ICRI to prevent future water penetration.

Figure C: Concrete spall at balcony slab edge in units 1008 & 211

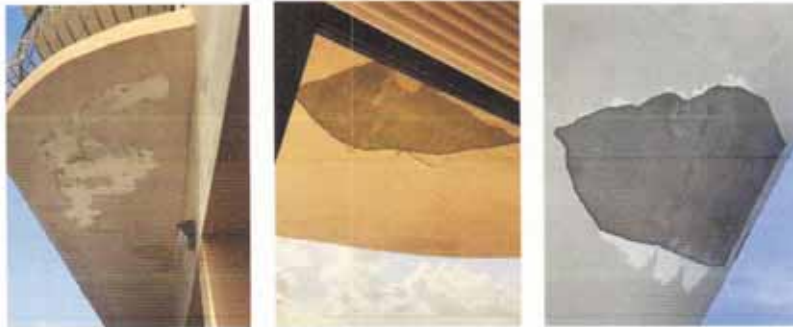
- D. Approximately half of the balcony soffits reviewed by MC show evidence of deterioration under the painted finished surface. These areas were identified by sounding the concrete with a golf club, checking for solidarity. In some cases, the paint finish had formed a bubble or pocket that was retaining water, while in other areas the painted soffit was peeled away leaving the concrete surface exposed. The extensive soffit damage is a systemic issue that can only be repaired by removing all of the balcony tile, repairing the damaged concrete surfaces at the top and bottom of the slab and protecting the slab by installing a pedestrian waterproofing membrane on all top-side balcony surfaces. Partial/full depth concrete repairs in these areas shall be performed in accordance with the recommendations of ICRI. It is important to note that installing tile on top of the concrete balcony surfaces results in the railing having inadequate height to meet the minimum guardrail height of 42" required by the Florida Building Code.

Figure D: Balcony Soffit paint spalling in units 208, 703, & 1301.

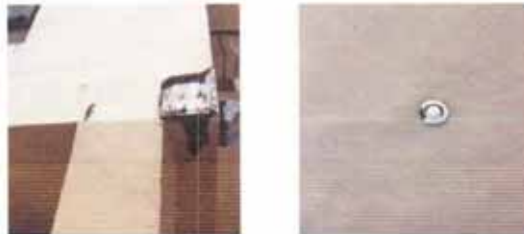
- E. Several areas of the entrance drive soffits under the second floor were observed by MC to have deteriorated black plywood. This condition was also observed at several light fixtures in the entrance soffit. MC could not get access into the soffit areas to observe the extent of the deteriorated soffits and support framing as CTS maintenance was too busy to assist us. MC is concerned that mold exists above these soffit areas and the soffit support framing is deteriorated which will require the complete removal and replacement of the entrance suspended soffit. Further investigation into this area is warranted.

Figure E: Deteriorated plywood soffit above entrance drive.

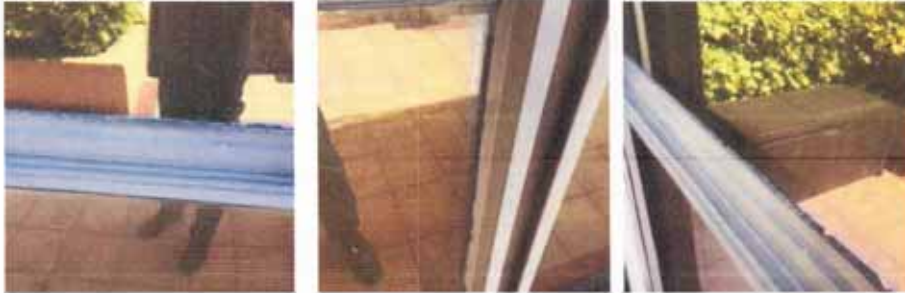
- F. It was brought to MC's attention that several units are experiencing water infiltration through the window frames and glazing as the windows are near the end of their functional lifespan. It is recommended that the window frame glazing (metal to glass), and perimeter sealant (metal to metal or metal to masonry/concrete) be removed and replaced for the entirety of the building to reduce future water penetration and minimize damage during hurricane events. MC recommends that the BOD strongly consider the replacement of all exterior windows and doors with impact resistant units.

Figure F: Exterior sealant at window frame that has aged past its serviceable lifespan

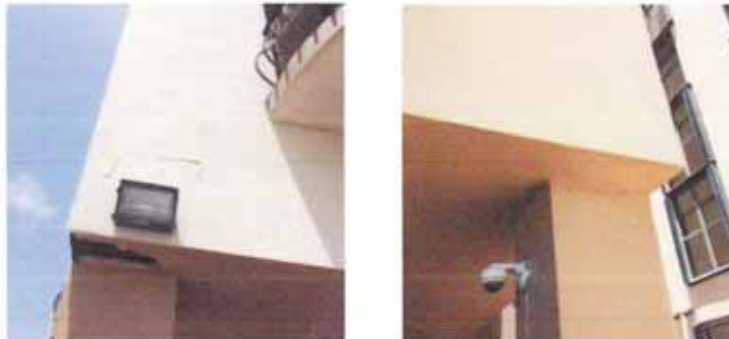
- G. Significant cracking in the stucco exterior façade often occurs at the mortar bed joint between the top of the concrete floor slab and first block masonry course. Although MC does not see this crack as a source of water infiltration into the condominium units, such cracks need to be routed and repointed to prevent future water permeation. All significant façade stucco cracking is to be repaired in accordance with the recommendations of ICRI.

Figure G: Typical cracking in the stucco exterior façade.

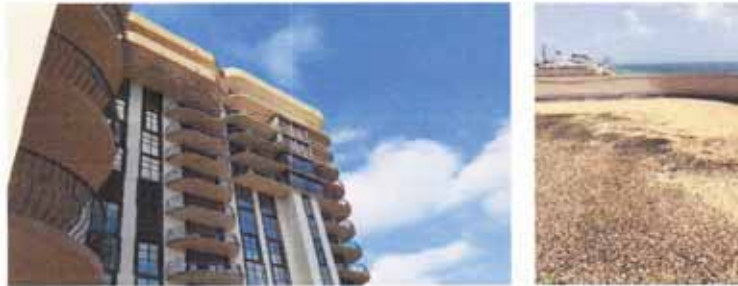
- H. MC observed the non-existence of window washing / suspension hooks that should have been installed face-mounted to the underside of the top-level balconies and spread throughout the roof of this building structure. This failure to have suspension hooks is a violation of the present-day **Occupational Safety and Health Administration (OSHA) Rules and Regulations 29 CFR Part 1910 "Walking-Working Surfaces and Personal Protective Equipment (Fall Protection systems)"** requirements and **ANSI/IWCA I-14.1-2001 "Window Cleaning Safety Standard"**. MC recommends that new hooks be installed and waterproofed on the roof structural slab and underside of the top-level balcony slabs that meet the requirements of **OSHA 29 CFR Part 1926.502 "Fall Protection Systems Criteria and Practices"** and **ANSI/IWCA 1-14.1** prior to the commencement of façade and balcony restoration. Furthermore, MC recommends that our office meet with the contractor who is to perform the façade restoration work and the present window washing contractor so that the new fall protection system anchor quantity and location can be agreed upon to assure adequate anchor coverage for all future contractors who will be suspended on the exterior of the Champlain Towers South Condominium.

Figure H: No suspension hooks at the underside of the balconies and on the roof.

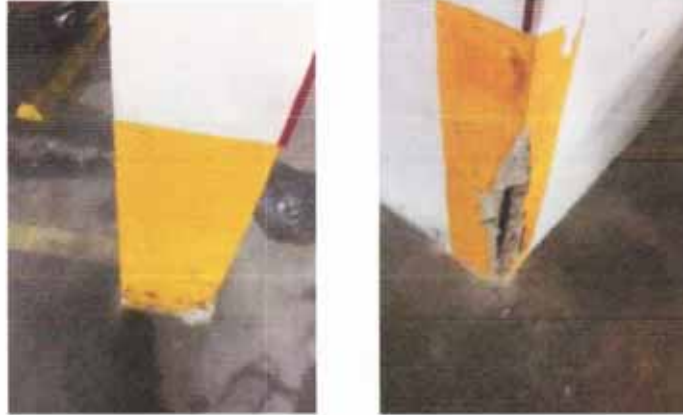
- J. Abundant cracking and spalling of varying degrees was observed in the concrete columns, beams, and walls. Several sizeable spalls were noted in both the topside of the entrance drive ramp and underside of the pool/entrance drive/planter slabs, which included instances with exposed, deteriorating rebar. Though some of this damage is minor, most of the concrete deterioration needs to be repaired in a timely fashion. All cracking and spalling located in the parking garage shall be repaired in accordance with the recommendations of ICRI.

Figure J1: Typical cracking and spalling at parking garage columns

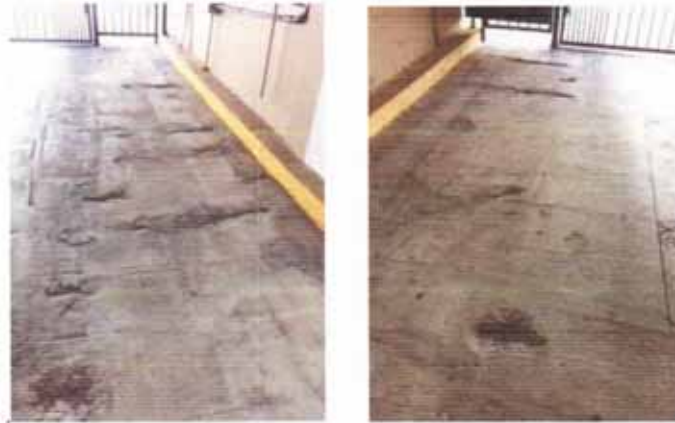
Figure J2: Spalling with exposed steel reinforcement at topside of garage deck.

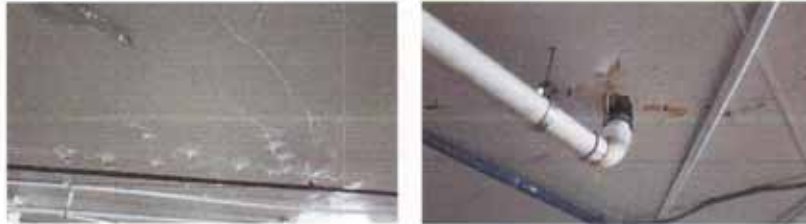
- K. MC visual observations revealed that many of the previous garage concrete repairs are failing resulting in additional concrete cracking, spalling and leaching of calcium carbonate deposits. At the underside of Entrance/Pool deck where the slab had been epoxy-injected, new cracks were radiating from the originally repaired cracks. The installed epoxy is not continuous as observed from the bottom of the slab, which is evidence of poor workmanship performed by the previous contractor. The injection ports were not removed, and the surfaces were not ground smooth at the completion of the injection. Leaching of calcium carbonate deposits in numerous areas has surely caused CTS to pay to repaint numerous cars. This leaching will continue to increase until proper repairs are completed. MC is convinced that the previously installed epoxy injection repairs were ineffective in properly repairing the existing cracked and spalled concrete

Figure K1: Previously installed failed injection repairs with leaching forming

slabs. MC recommends that the Entrance/Pool deck concrete slabs that are showing distress be removed and replaced in their entirety. Unfortunately, all of these failed slab areas are under brick pavers, decorative stamped concrete and planters which require completed waterproofing replacement. All repaired concrete slabs located in the parking garage are to be repaired in accordance with the recommendations of ICRI.

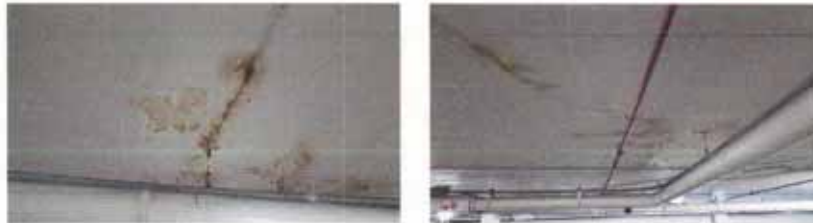
Figure K2: More previously installed failed injection repairs with leaching forming
