KEY TO THE INSPECTION REPORT

Report: 1234 Ash

INSPECTOR : Mike Doe

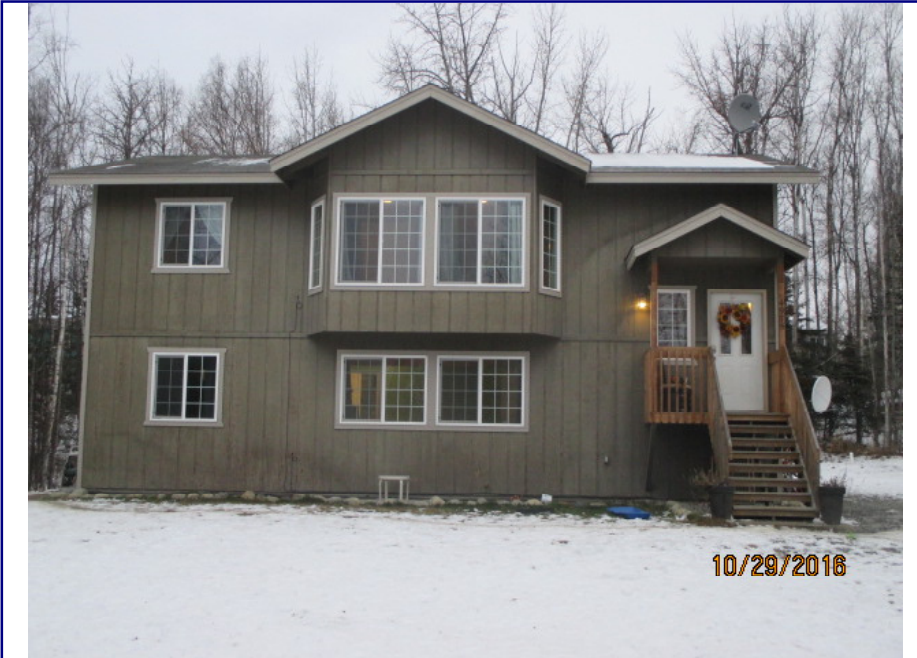
Picture 1

Home Front.

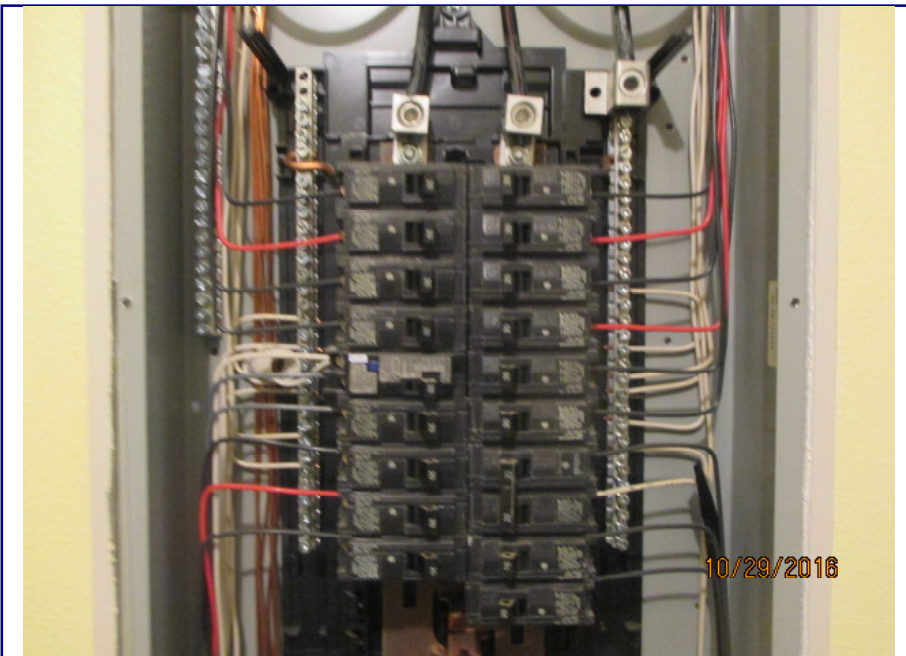
Picture 2

Not enough AFCI.
