CORRECTIVE ACTION REPORT

Inspection Date	02/23/2015	Project ID	D0005275807
Completion Date	11/11/2012	Project Type	Single Family Home Performance
Contractor Name	Energy Services Co.	Customer Name	Jane Smith
Contractor Phone No	(518) 252-6012	Customer Address	123 Main St Utica, New York 13501
Contractor Email	energyservicesco@gmail.com	Customer Phone	((518) 447-4665

Based on a quality assurance post-completion inspection, the following items require action and must be resolved within 30 days.

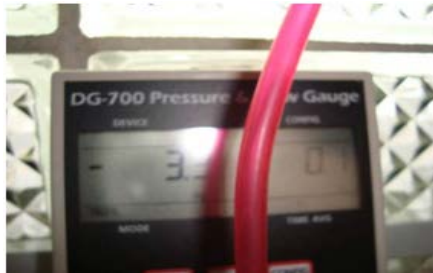
Task Correctly Measured CAZ(s) De-pressurization

Failure Description CAZ fails the depressurization limit, but the appliances still pass spillage and draft under worst case. Or, the CAZ fails the depressurization limit, and under natural conditions the appliances fail spillage or draft

CAZ failed WCD

Worst-case CAZ depressurization limits were exceeded during testing. Recorded reading was -6.5. BPI limit is -5

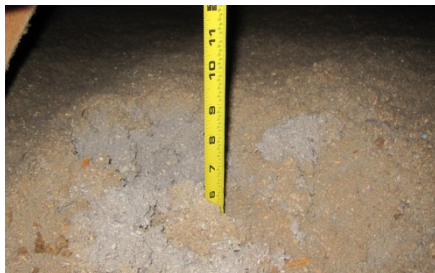
Task Specified R-Value And Quantity Installed

Failure Description Less than 80% of billed insulation was installed

The installed R-Value does not match the invoiced amount.

Notes: The contract was for 10 inches of cellulose but 6 inches of new insulation was installed.

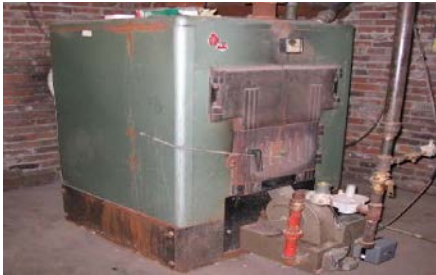
Task Equipment Removal

The old furnace was not removed from the basement and was included in the contract
