Crawford Inspection Services

BUILDING INSPECTION REPORT

Sample Inspection Report

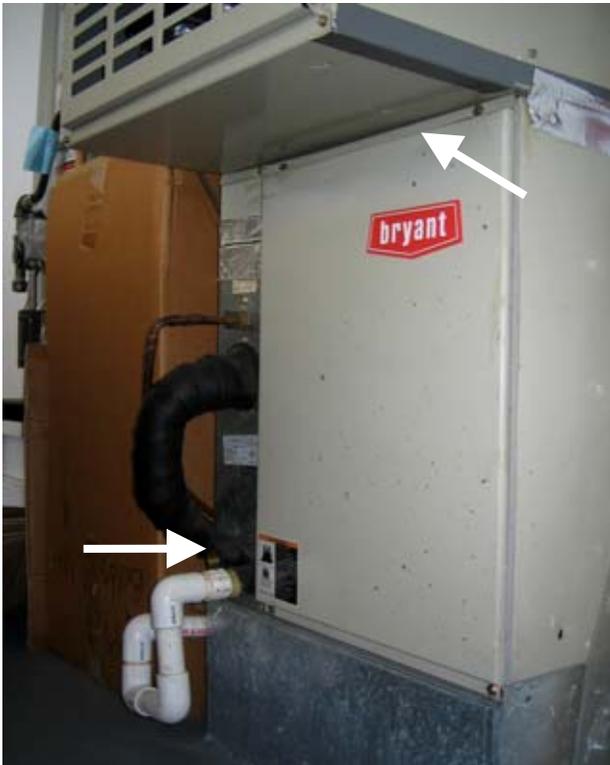
Significant air leakage was noted from the air conditioner box below the furnace in the garage. The seam between the box and the bottom of the furnace should be sealed and a threaded port at the bottom of the A/C box should be plugged to prevent excess energy loss.

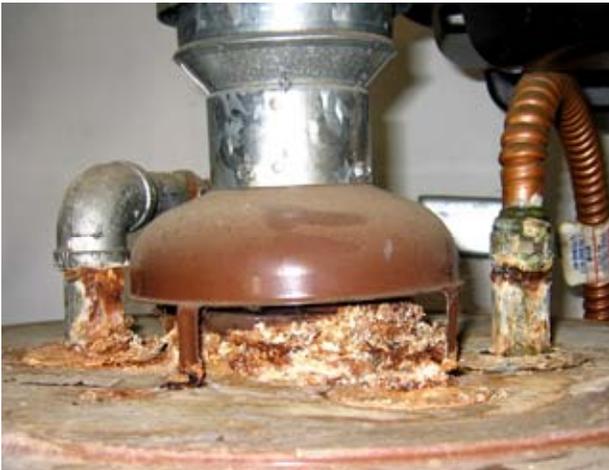
Heavy corrosion was noted on both water pipe connections on top of the water heater and around the flue. The water pipe connections were leaking at the time of the inspection. It is recommended that the pipe connections and the flue be further evaluated by a licensed plumber and corrections made, as needed.

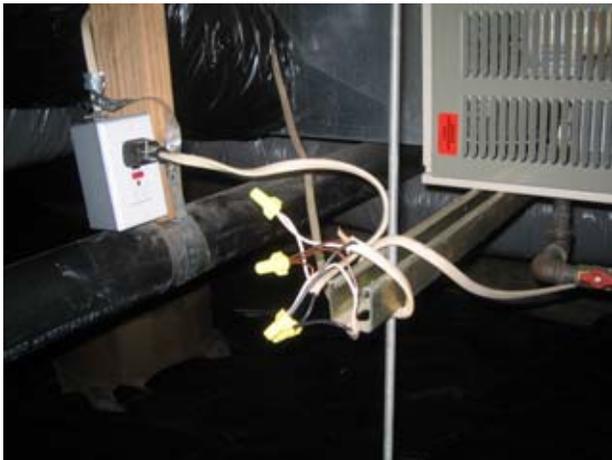
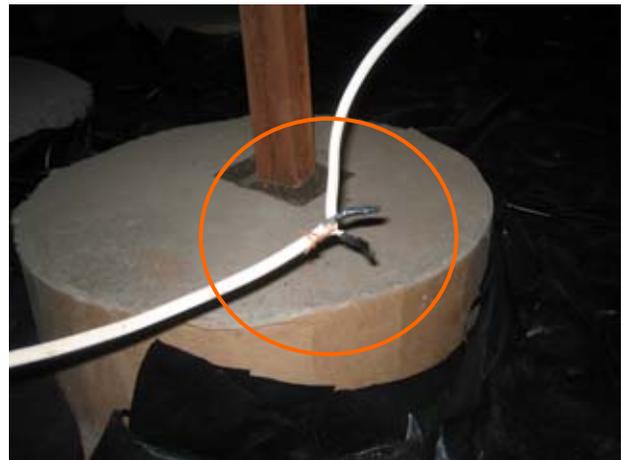
- New circuit cables have been unprofessionally installed in the crawl space. These added cables were installed improperly and should be replaced by a licensed electrician for safety. See photos below.

Unprotected cable splices in the crawl space.

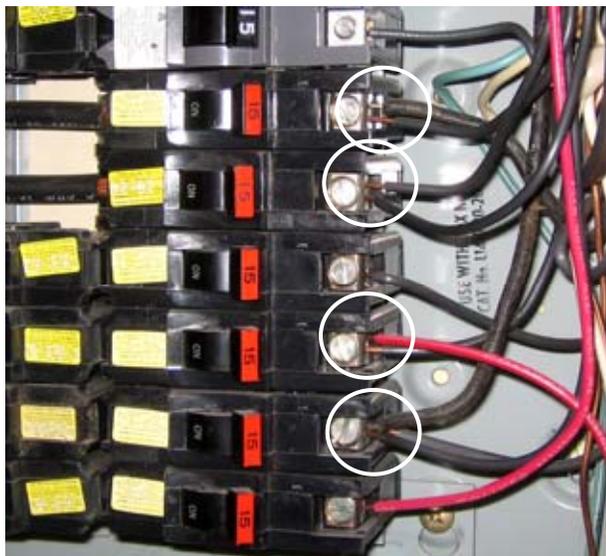
Double-and triple tapping (two or three circuits on the same circuit breaker) was found in the panel. Each circuit wire should be connected to its own breaker to avoid loosening of the wires at the breaker terminal. When the wires become loose, an electrical arc can occur, creating a potential fire hazard. Nuisance tripping due to overloading may also occur.

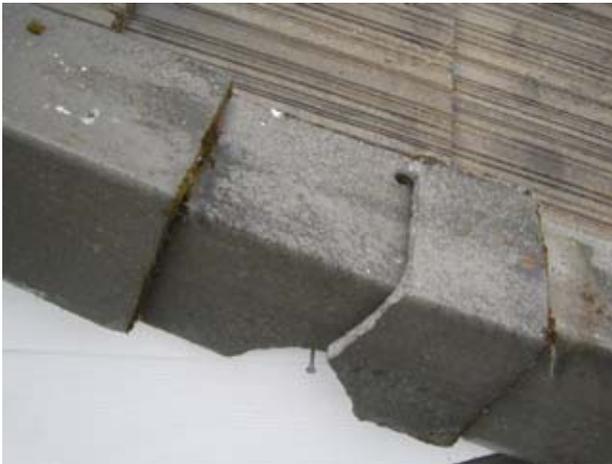
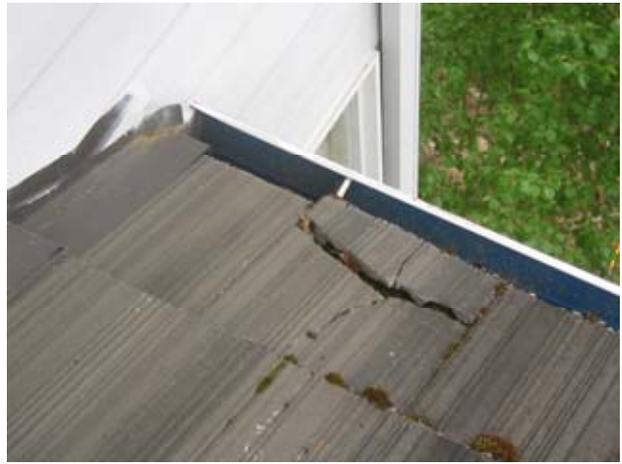
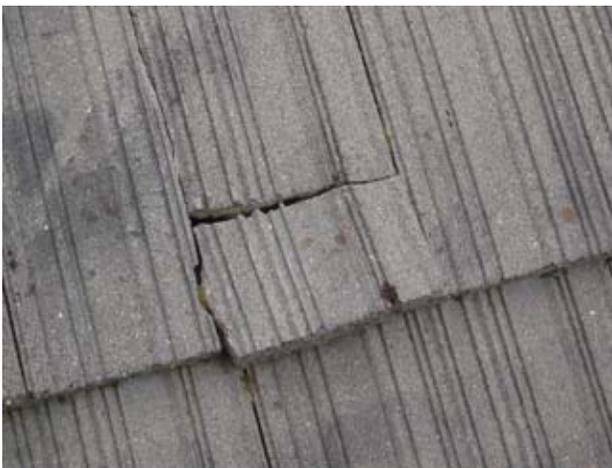
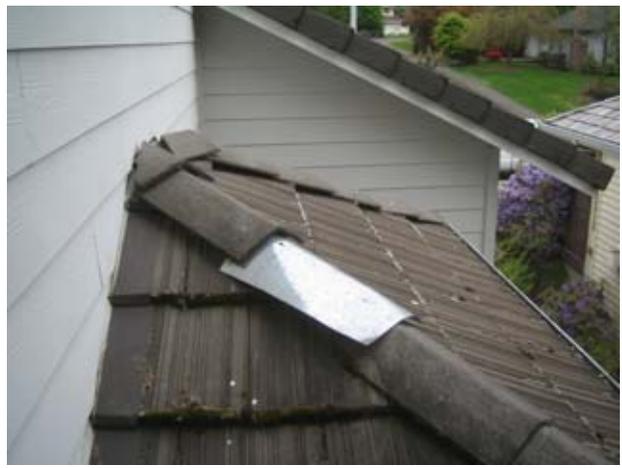
- Broken roof tiles were noted in several places. It is recommended that the entire roof surface be inspected by a qualified roofing contractor and that all damaged, cracked, or missing tiles be replaced. All moss on the roof should be removed.
