## Evaluation of Chloride Corrosion Reduction With Chemical Additives at Maine Energy Recovery

J. David Martin  
Fuel Tech, Inc  
512 Kingsland Dr  
Batavia, IL 60510  
[dmartin@fueltechnv.com](mailto:dmartin@fueltechnv.com)

Ken Robbins  
Maine Recovery Company  
PO Box 401  
Biddeford, Maine 04005  
[ken.robbins@casella.com](mailto:ken.robbins@casella.com)

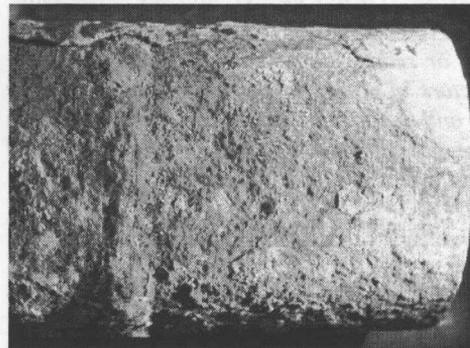
The corrosion problem at MERC currently can be described as isolated to about 5% of the superheater pendant surfaces which experience corrosion rates ranging from 0.020 to 0.050 inches per month and that this results in tube failures

as early as 7 months into a run and the need for replacement of the entire pendant annually. A photo of a recently removed tube with a failure is shown in Figure 1. The pattern of metal loss is illustrated in Figure 2 where severe metal loss is shown on opposite sides of the tube. An observation of the plant is that this thinning which is on the sides tangential to flue gas flow occurs on opposing tubes and these tubes show similar metal loss.

FIGURE 1 - Close-up of rough, wasted surface covered with friable corrosion product layers.

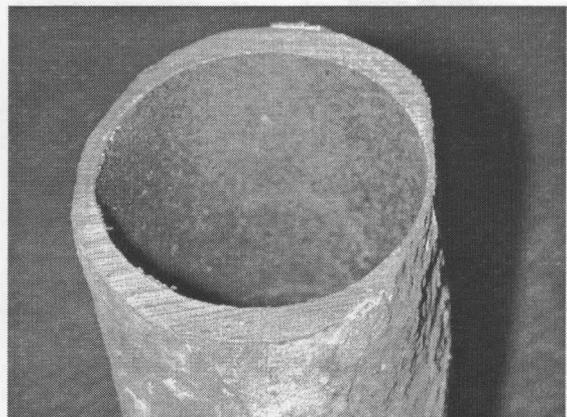
FIGURE 2 - Deep, general metal loss along opposite sides
