Possible Electrical Transformer Defect

Technical Bulletin Reference No. 2110-001

Delta III Metal Bonnet Update

Technical Bulletin Reference No. 2110-002

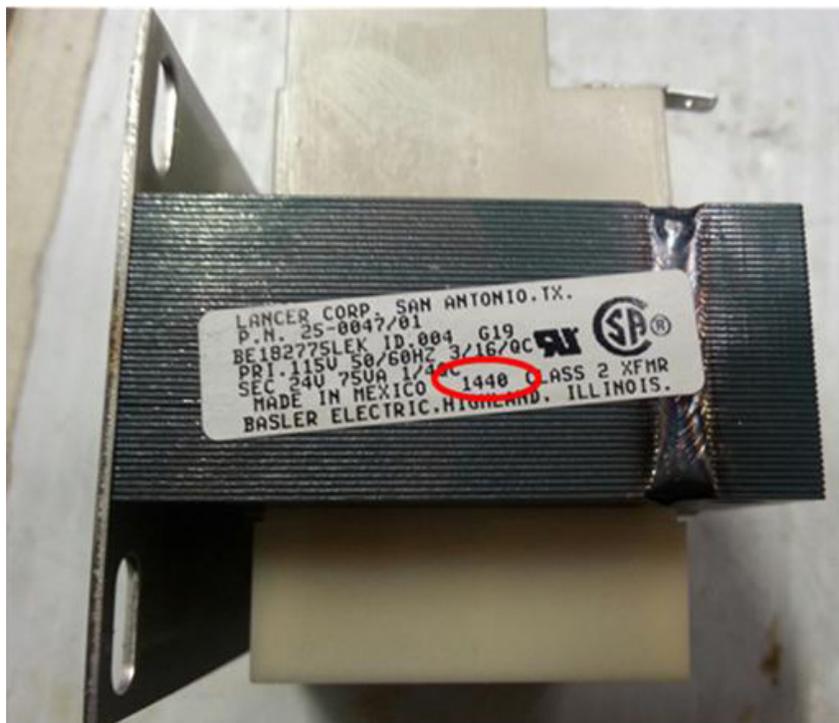
Basler has identified the effected date codes for their Transformers (Lancer PN 25-0047/01 or CCPN 25609). The datecodes between 1435 to 1446 are defective and should be replaced. The transformer date code can be found on the manufactures label locate on the component itself (see below). Lancer has already identified all impacted equipment with these effected transformers.

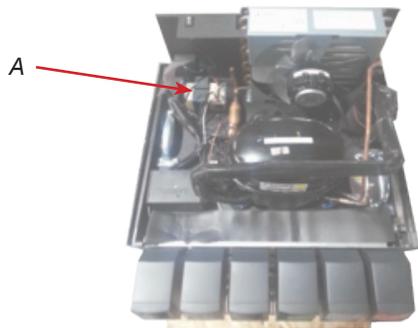
3. Locate the effected transformer.

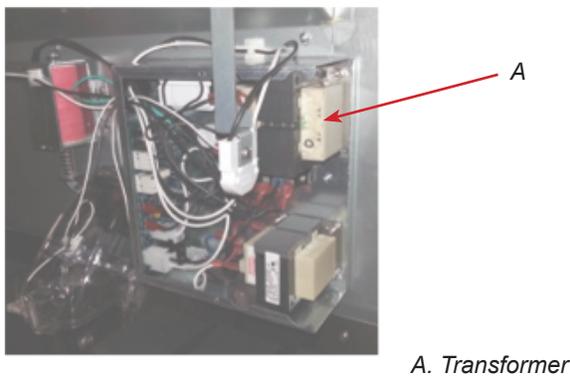
5. Locate the effected transformer inside the control box toward the right of the unit.
