MPTA-C8c-2011 R2021

COMMON CAUSES OF SLEEVE
COUPLING FAILURES

MPTA INFORMATIONAL BULLETIN

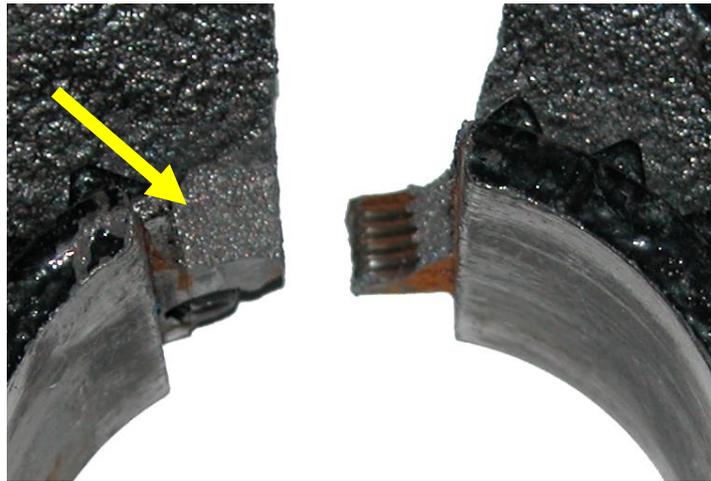
Figure 2

A keyway burst failure can be caused by four possible situations. The first is due to the hub being subjected to an over torque condition. The weakest point in the hub is usually over the top of the keyway where there is the smallest cross section of material between the top of the keyway and the outside diameter of the hub. This is where an overload fracture is most likely to originate (Figure 2).

The second condition where this can occur is when a hub is forced onto a shaft in an interference fit condition or the key is too large. The pressure from this interference fit will cause the hub to burst at the weakest point which is typically at one of the top corners of the keyway.

The third condition occurs when there is excessive clearance between the hub and shaft, allowing relative motion between the hub and shaft.

The fourth condition is when the bore size exceeds the manufacturers recommend maximum bore limit, resulting in a very thin cross section from the keyway corner to hub outer diameter.

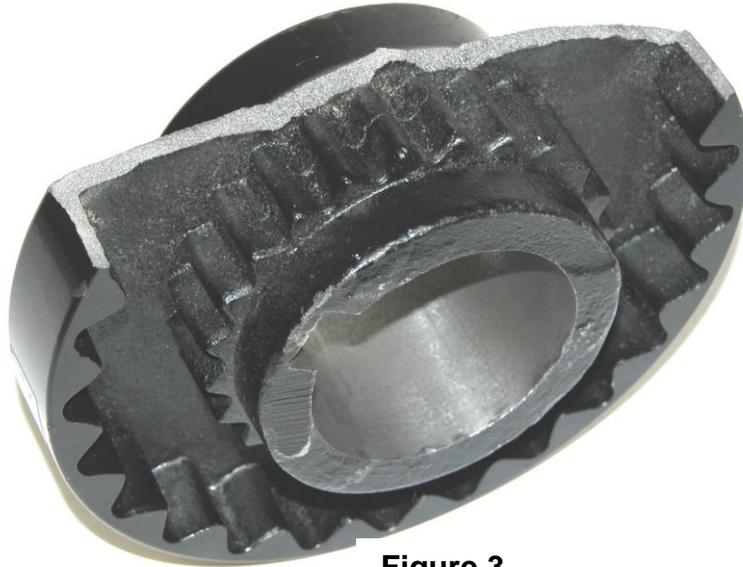
A fracture may occur across the face of a flange. This may be attributed to a material defect, or when the flange is subjected to improper installation practices with installation abuse. Use of improper, or abusive techniques during installation, such as aggressive hammering can cause cracks in the face of the flange. These cracks can fracture during the installation as can be seen in Figure 3 or in the presence of any sizable load when placed into operation.

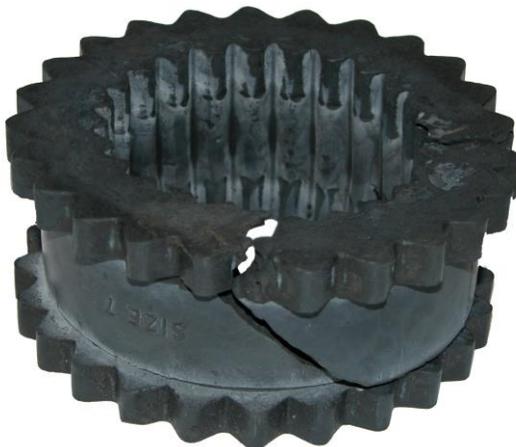
When the elastomeric sleeve is subjected to a high cyclical torsional load, the sleeve will fail or tear in a classical diagonal pattern as shown in Figure 4 and Figure 5. This failure mode is indicative of torsional fatigue and is typically seen on applications subject to shock loads or frequent start / stop cycles.

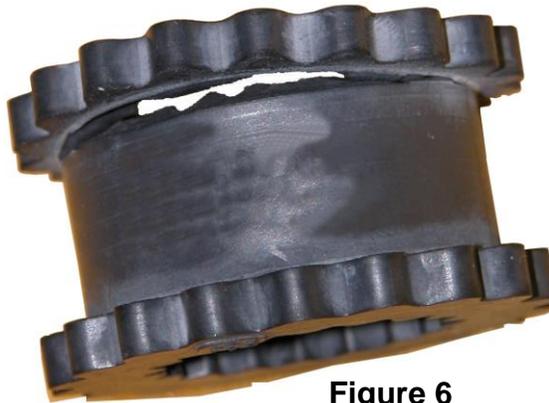
Straight tear failures (Figure 6) typically occur along a stress line between the teeth and the center section of the sleeve. These are sometimes caused by material defects created during the mold process of the sleeve.

This type of failure can also occur as the result of fatigue from misalignment, particularly when the hubs are installed too tightly together against the sleeve. Usually the fracture occurs completely across the sleeve prior to detection. The sleeve in Figure 6 was observed early prior to complete separation.

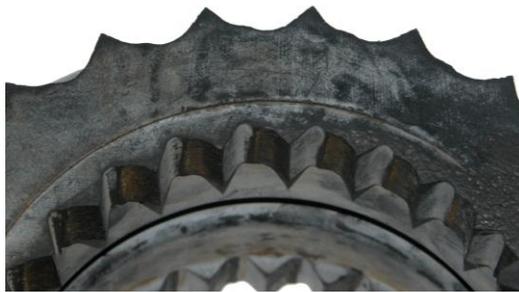
Figure 7

When the coupling is properly applied, and aligned, the sleeve will operate with some amount of torsional “wind-up”. Under operating torque, this “wind-up” causes the sleeve teeth to grip the mating teeth on the flanges. Under these conditions, misalignment is accommodated through flexing of the elastomer sleeve. When the coupling is significantly oversized (service factor higher than 4.0), or the misalignment exceeds recommended limits, the sleeve does not grip the flanges. In this case, misalignment will result in relative motion between the sleeve teeth and flange teeth. This causes abrasive wear of the teeth as shown in Figure 7. If the wear is not detected relatively early, the sleeve will wear to the point that the teeth can no longer transmit torque, the sleeve will spin inside the flange and the teeth will wear off completely as in Figure 8.
