Service Bulletin

American Honda Motor Co., Inc.

2001-2008 GL1800 Trunk Opener Unit, Opener Rod & Snap

(This supersedes GL1800/A #15, dated May 2004)

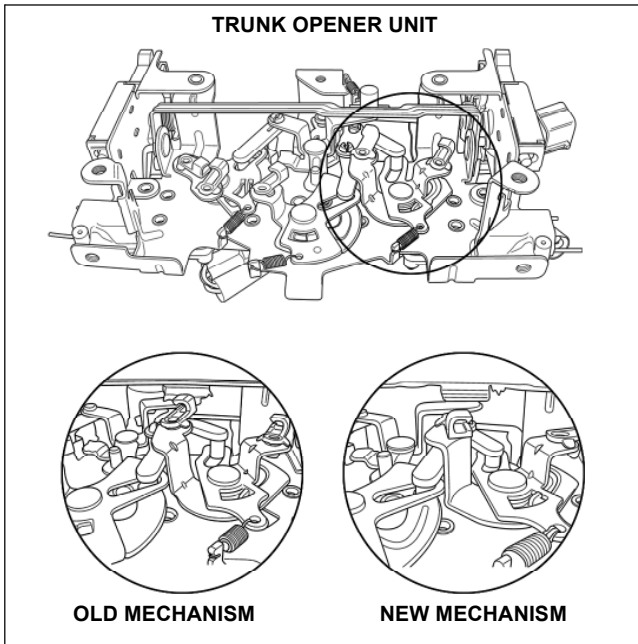
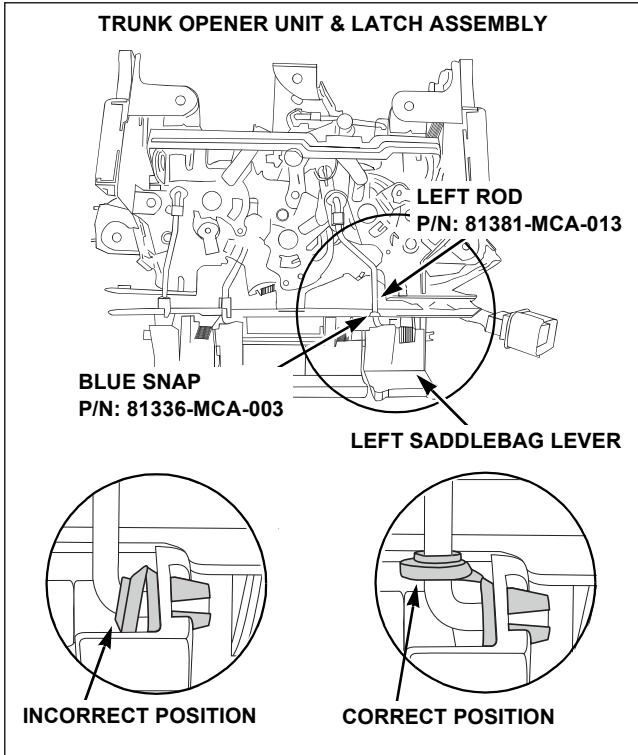
PARTS DESCRIPTION

During production for the 2008 model year, the trunk opener unit was modified with a new, redesigned left opener rod (which runs from the opener latch lever to the opener body) and a new blue snap (which fastens the rod to the latch lever). The blue snap replaces a green snap that may experience breakage.

New Opener Rod & Blue Snap: After placing the rod through the snap, be sure to move the hinged portion of the snap around the L-shape of the rod to avoid possible function loss. See the illustrations on page 2.
