Digital Asset Integrity Monitoring Program Yields >\$4M Win with Asset Life Extension in SRU

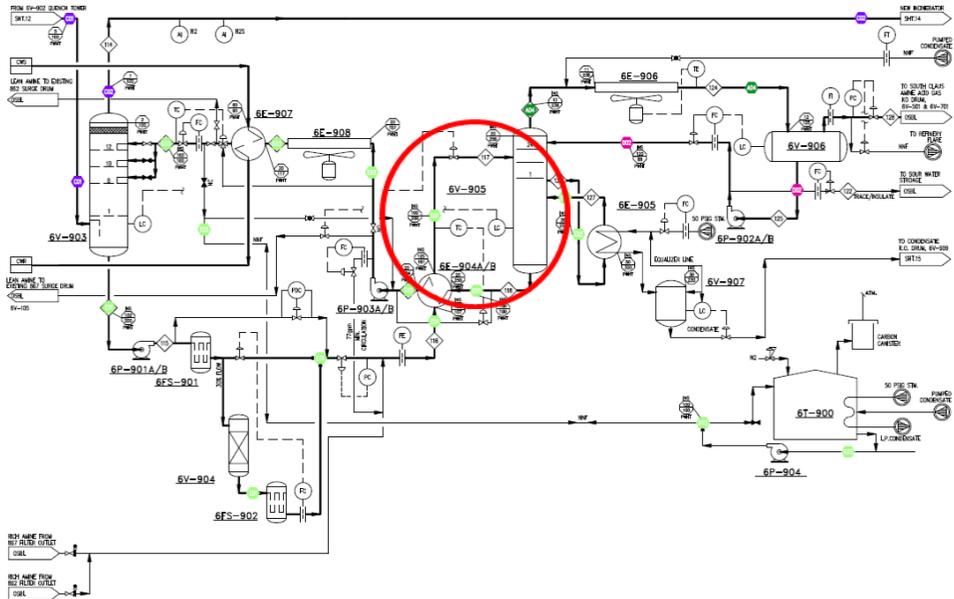
During the Amine Treating process, the “sour” gas (H₂S or CO “rich”) counter flows the clean (“lean”) amine liquid and absorbs the gases. In this continuous cycle, corrosion may occur due to high Heat Stable Amine Salts (HSAS) that will form over time. In addition to this mechanical erosion damage, other areas may “flash” gases due to pressure drops and cause severe highly localized piping wall loss. As suggested in industry Recommended Practice API 571, HSAS above 2 wt.% may cause corrosion high rates and depending on velocity, this may occur at lower concentrations and higher flow rates. H₂S is corrosive because they lower the pH, increase solution conductivity, and can destabilize the protective sulfide layer (film) in equipment/piping. HSAS, in high flow or coupled with areas of high turbulence/changes in flow also cause tremendous, localized wall loss erosion-corrosion. In this case, it was determined that the design of a nozzle in the horizontal position of the exchanger is a bad industry design and causes turbulence (eddy’s) that increase the corrosion rate in specific areas.

Figure 2: Piping & instrumentation diagram with affected areas highlighted

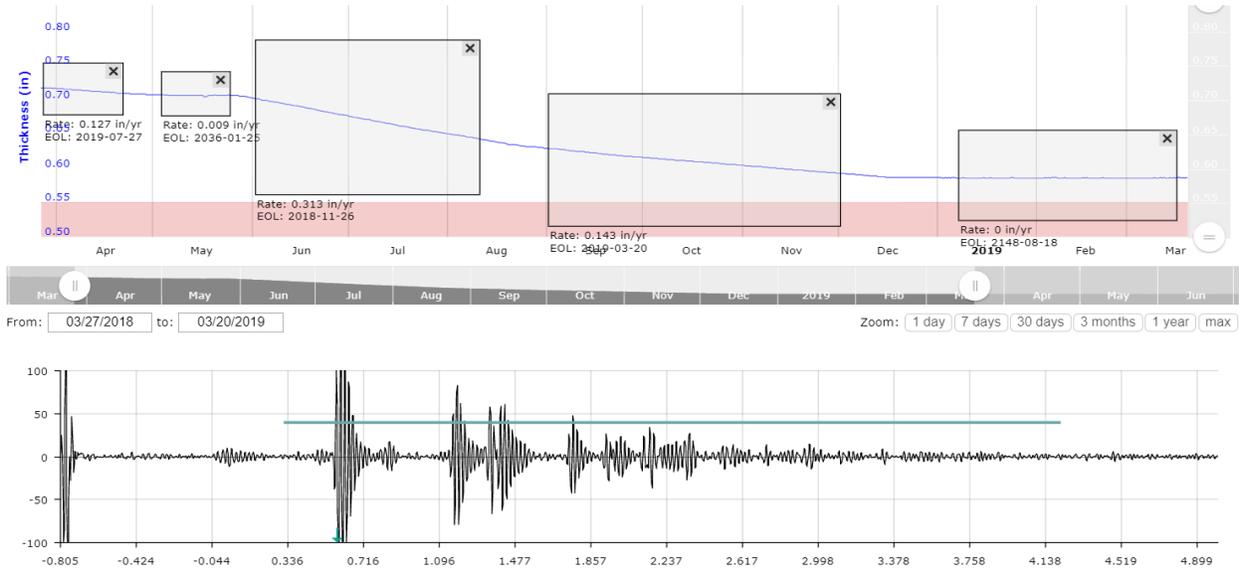
Figure 3: Upper graph: Thickness data (Y-axis) collected over twelve months (x-axis). Lower graph shows Ultrasonic wave form for to make precise (+/- .001") thickness readings from sensor

The Outcome: Using the monitoring approach via installing wireless UT sensors, the asset owner was able to quickly (about one month) and accurately (to within .001") trend the corrosion rate at each point where the sensor was located. Further, with the help of the operations and corrosion teams, the asset owner was able to tweak process parameters to remediate or reduce the corrosion at this location of the unit. See below in figure 4, a picture of one of the wireless UT sensors.
