Fracture of Both Rods of a Malleable Penile Prosthesis: A Case Report

Berat Cem Özgür, Asım Özayar, Musa Ekici, Mehmet Çiftçi, Hasan Bakırtaş
Ankara Etlik İhtisas Eğitim Araştırma Hastanesi Üroloji Kliniği, Ankara, Türkiye

J Clin Anal Med 2014;5(2): 154-5

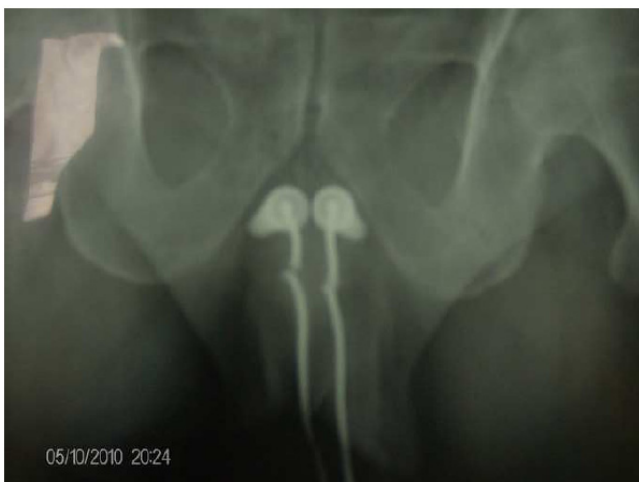
A 66 year old man was admitted with a dull aching and non radiating pain in the penile region during the sexual intercourse of three months duration. There was no history of trauma or abnormal use. Physical examination revealed dislocation of the rods of the penile prosthesis. Laboratory studies revealed normal hematological and biochemical profile. Pelvic radiography and magnetic resonance imaging (MRI) showed fracture and dislocation of the rods of the penile prosthesis. He was prepared for surgery. A broad spectrum antibiotic was given preoperatively. Penile surgery was performed in the supine position under spinal anesthesia with a circumferential subcoronal degloving incision. The tunica was opened and removal of the prosthesis followed by insertion of the new; same sized one eventfully (Figure 1-2).

Figure 1. Bilateral fracture in the plain radiograph.

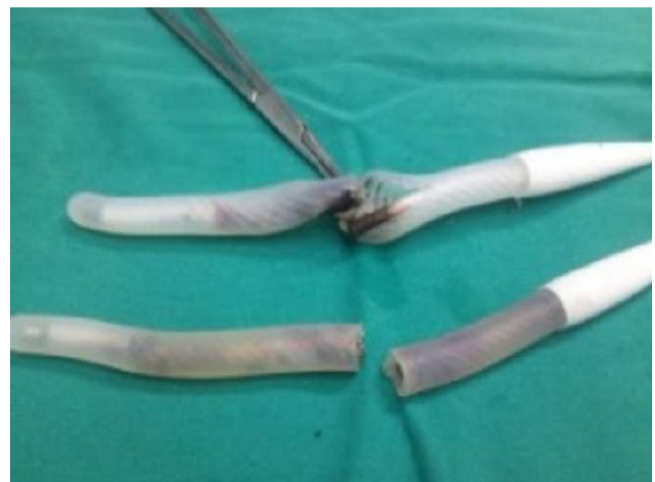
Figure 2. Fracture detected after the prosthesis removal.
