Firm Capabilities: Monument Conservation - HMS Macedonian Monument, U. S. Naval Academy, Annapolis, Maryland

Project: Aeon Preservation Services LLC was hired by the U.S. Naval Academy Foundation to perform a comprehensive assessment and treatment program for the HMS Macedonian Monument located at the south end of Stribling Walk in the heart of the Naval Academy campus. Aeon was initially brought in by Direct Dimensions Inc. on a project involving the laser scanning and replication of the figurehead. Aeon was subsequently hired to manage the restoration of the monument erected in 1924 to commemorate the capture of the HMS Macedonian during the War of 1812. The monument was composed a painted wood figurehead taken from the ship as well as four late Eighteenth century cannon, several bronze plaques on an ornamental concrete base. Aeon was hired to document, analyze, and treat the monument on a design/build basis.

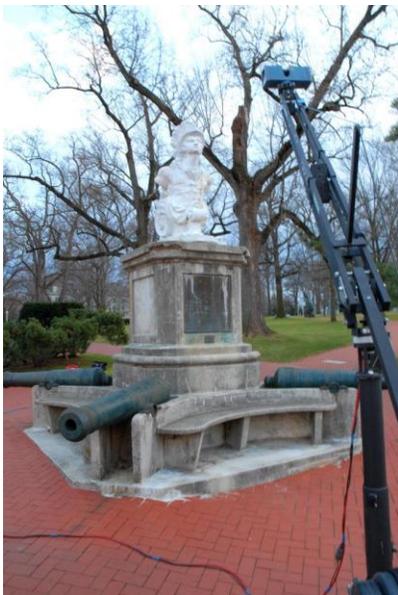
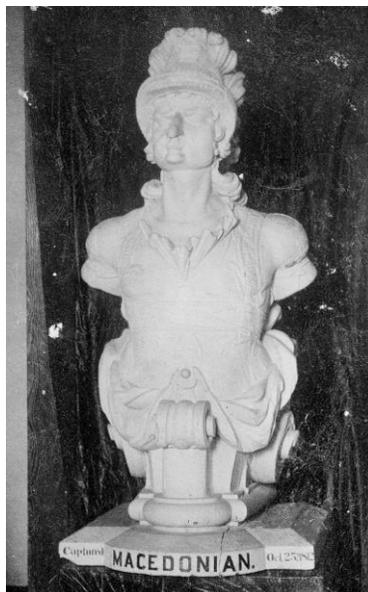
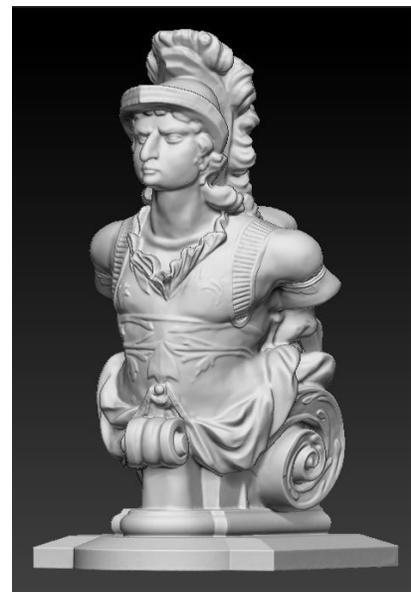
Pre-restoration view with laser scanner; historic image of figurehead; digital model of figurehead

Aeon worked closely with the SHPO and NPS to craft and implement a treatment strategy that met the requirements of the Navy while respecting the historic integrity of this unique monument. The monument was dismantled and each component treated in a manner best suited for each element. The original figurehead had been encased in fiberglass in the 1960s and was in poor condition. The original was laser scanned, digitally restored based on historic photographs, and a replica wood figurehead carved (with the original moved indoors for safekeeping) and installed. The bronze plaques were stripped of corrosion and encrustations, repatinated, and waxed. The ornamental concrete was restored using Jahn patching mortars to match the original appearance and texture including casting new benches, cap, and cannon supports. The four cannon underwent full conservation treatment in Aeon's shop prior to being refinished and reinstalled. This involved coating removal, a five-month electrolytic chloride reduction treatment, iron phosphate conversion, and recoating.

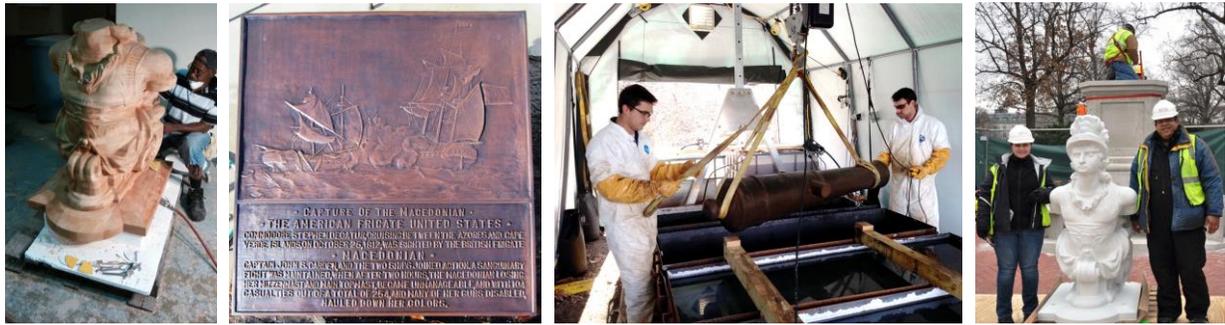
Milled wood figurehead replica; restored plaque; cannon conservation; replica figurehead installation

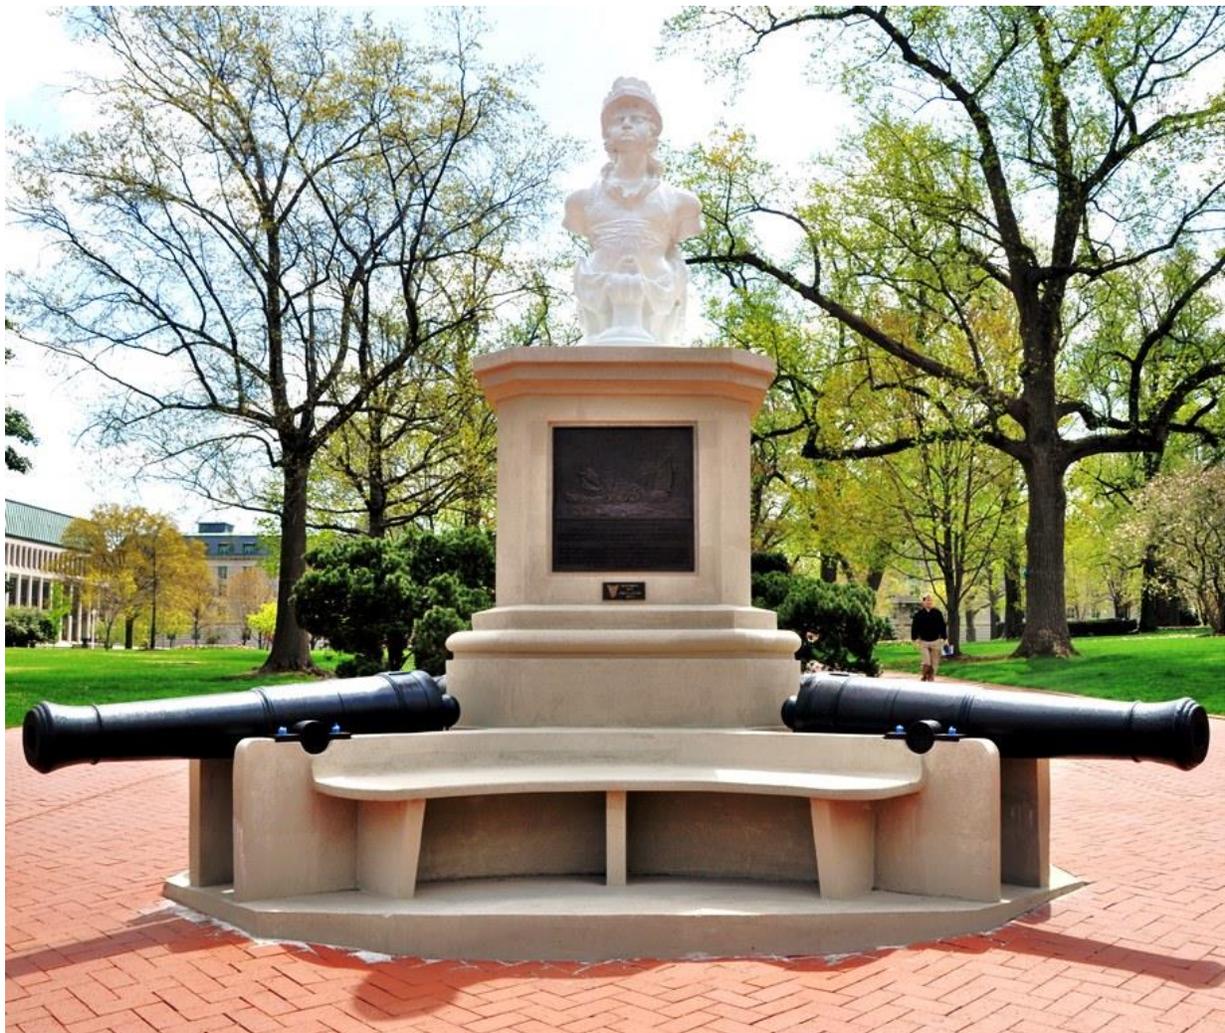
Restored monument after concrete restoration and reassembly
