Case Stories

High ohmic earth fault

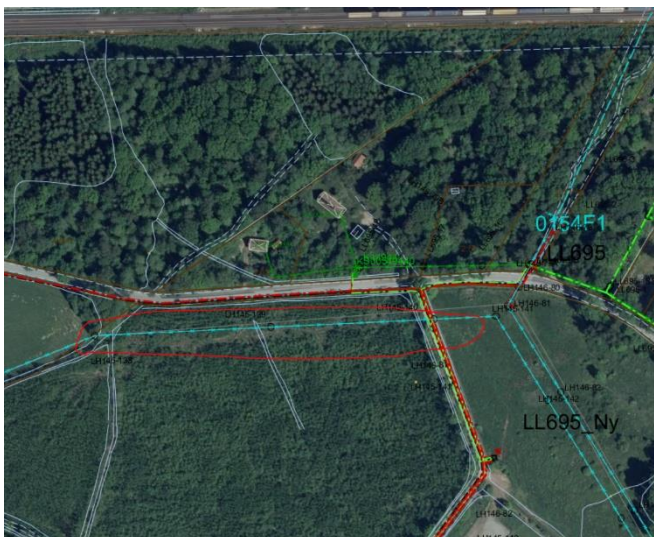
In one of the feeders of a primary substation located in a rural area, 17 incidents of recurring high ohmic earth faults (>8 kΩ) were registered over the course of about 1 hour.

Directional earth fault protection ($I\phi > I_{oint}$)	
Parameter	Measured value
Operate delay time	0 s, 0%
Measured value U0	675.1 V (0.106 pu)
Measured value 3I0	0.6762 A
Fault resistance	8396.2 Ohm
Settings ▶

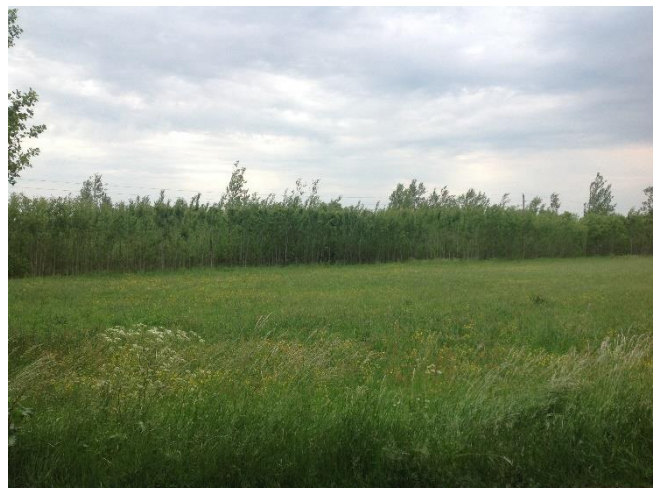
A quick overview of the map identified a possible area as the source of the incidents. A team was dispatched to investigate the line going through the wooded area. At the scene, the team was able to quickly determine that an energy forest planted below

the lines, had grown wild. At the slightest wind, the tops repeatedly touched the overhead line.

A trimming of the treetops in the energy forest was conducted and a potential outage prevented.
