Cross-section Paint Microscopy Report Exterior Paints

Tobias Lear House Portsmouth, New Hampshire

Date: August 27, 2019

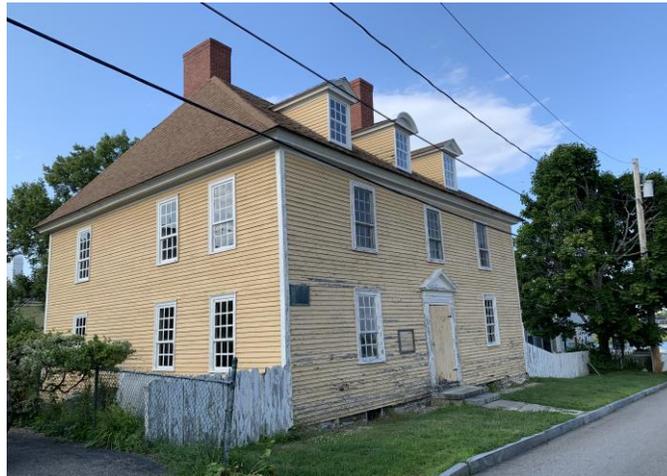
South and West Elevations

The condition of the exterior paints is fragile and paints are actively flaking on many areas of the clapboards. The paints on the trim elements appear somewhat more intact than the clapboards, although there are accumulations of soot and grime, as well as blackish mold spores on many areas. The building has not been repainted for many years, but several neighbors observed to Stephen Foster that they had always known the house as being painted yellow.

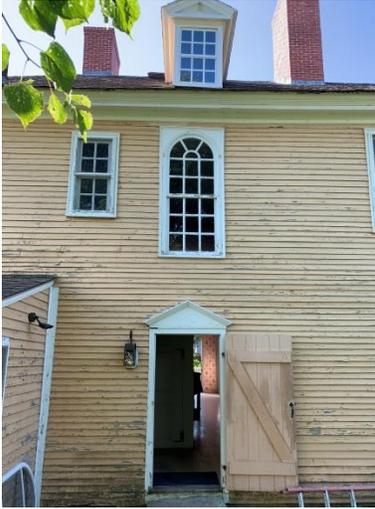
Rear Elevation

One original clapboard, one sash and three different trim elements were sampled to search for the original 1760s paint on the rear elevation.

1. North elevation, arched window, backband molding, left side.
2. North elevation, arched window sash, upper portion of window, top left corner.
3. North elevation, window trim, top left corner of backband.
4. North elevation, clapboard above arched window.
5. North elevation, fascia of cornice.

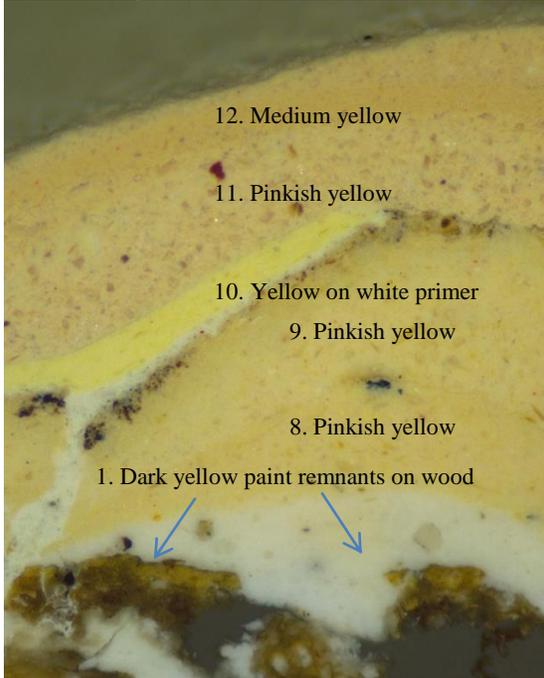
4. North elevation, clapboard above arched window.

Cross-section sample 4 from the clapboard retains convincing evidence of the original coarsely ground, dark yellow paint on the clapboards. There are only isolated fragments of this dark yellow paint on the 1760s rear elevation, but it is directly on top of the wood, and is consistent in composition and weathering with an exterior paint of that period. This original paint could not be confidently separated out for pigment identification using plane polarized light microscopy, but in cross-section the coarse, irregular, dark yellow pigments are consistent with yellow ochre and raw sienna, in combination with white lead and calcium carbonate. Binding media analysis with biological fluorochrome stains confirms that all the paints contain oil components.

The paint layer stratigraphy is the clapboards are weathered and disrupted, but there are still six generations of yellow paints which range in color from the original dark yellow, to pinkish-yellow, bright yellow and medium yellow. Most of the earliest paints are missing in this clapboard sample, likely from weathering and deliberate paint removal. So, the pinkish-yellow paint directly on top of the original paint was numbered as generation 8 because this same paint was found as generation 8 on the trim (see sample 1).

Visible Light 100X

Visible Light 200X

Ultraviolet Light 100X

UV Light & DCF for oils 100X
+ for oils in all paints

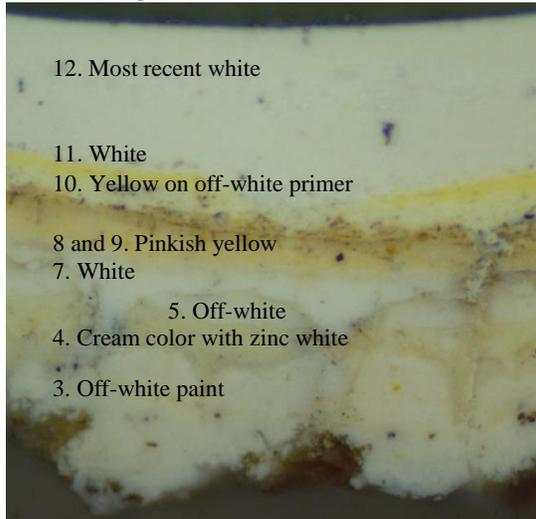
1. North elevation, arched window, backband molding, left side.

The comparative paint evidence suggests that the trim matched the clapboards in generations 8, 9 and 10 as the same yellows were found in samples 1, 3 and 5. Cross-section 2 from the sash shows that it was generally painted off-white and cream-colored like the trim, however, the sashes were black in generation 5 when the trim was off-white, and cream-colored in generation 10 when the trim was yellow. Generation 4 in this trim paint chronology contains the pigment zinc white (identified based on its characteristic sparkly autofluorescence), which dates this layer to after about 1845 when zinc white became commercially available.

Visible Light 100X

Ultraviolet Light 100X

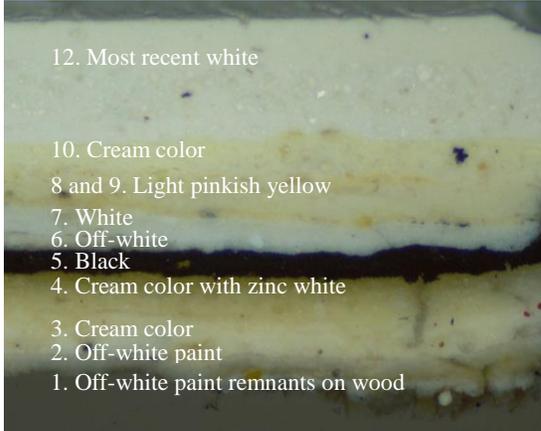
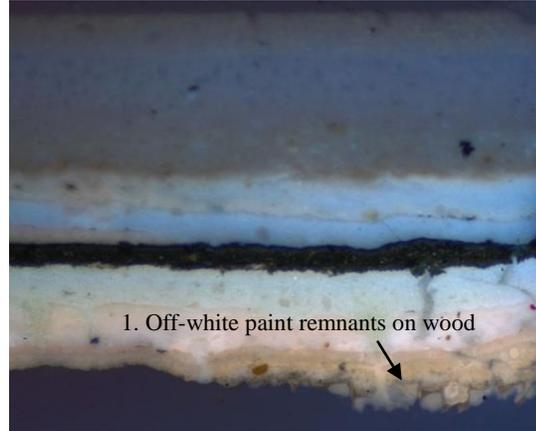
2. North elevation, arched window sash, upper portion of window, top left corner.

Samples 2, 3 and 5 contain remnants of the original off-white paint on top of the wood substrate. This paint is also dirty and fragmentary, but it is trapped in the wood fibers (see sample 5 from the cornice), confirming that it was the first paint applied to the trim elements. The pigments could not be confidently separated out because the original off-white paint is compromised by penetration of later coatings, but the pale pinkish- yellow autofluorescence of the earliest off-white paint is typical of a white lead-based paint in a linseed oil binder. The presence of oil in all the paints was confirmed with the fluorochrome DCF (see sample 5).

Visible Light 100X Paint flake

Ultraviolet Light 100X

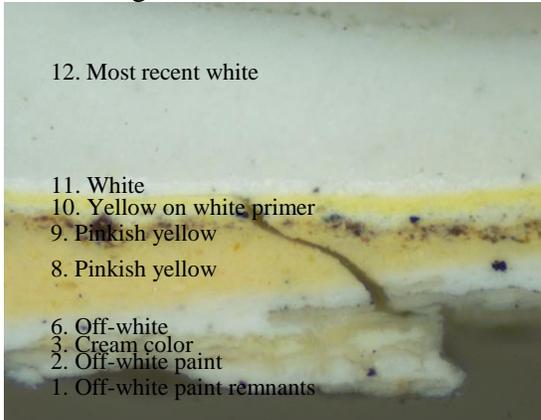
3. North elevation, window trim, top left corner of backband.

Visible Light 100X

Ultraviolet Light 100X

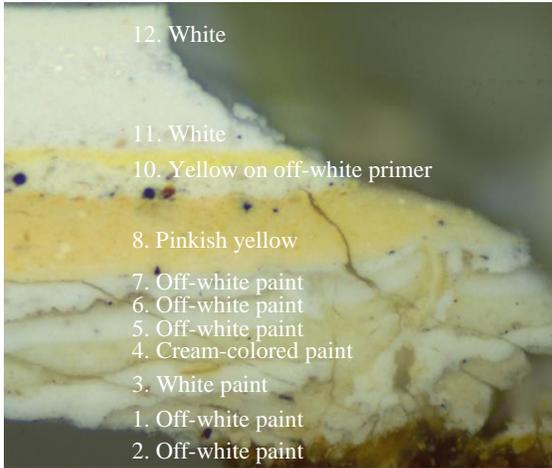
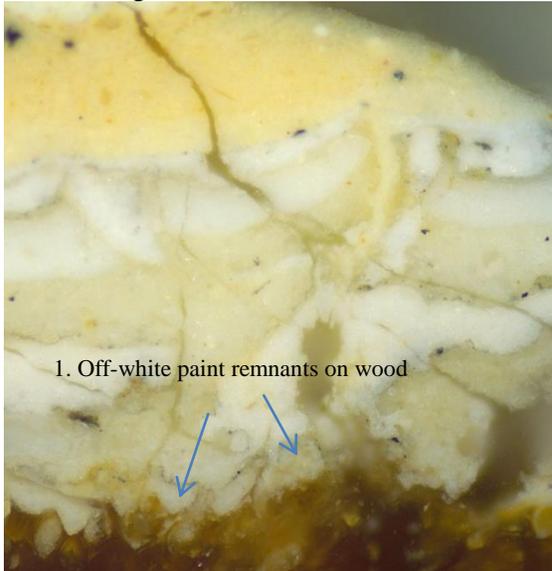
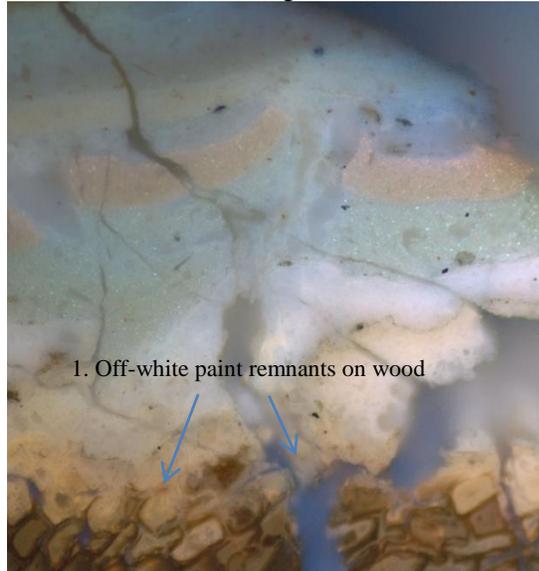
5. North elevation, fascia of cornice.

Visible Light 100X

Ultraviolet Light 100X

Visible Light 200X

Ultraviolet Light 200X

UV Light & DCF for oils 200X
+ reactions in all paints

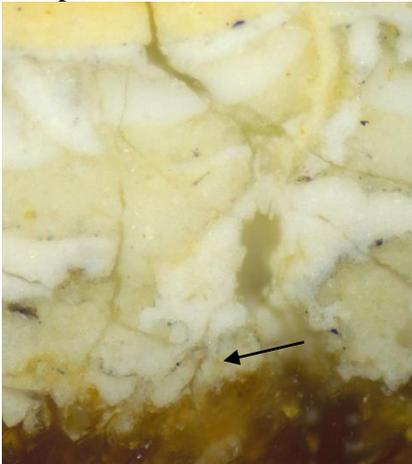
Sample 5

Generation 1. Original off-white paint on the 1760s trim

Benjamin Moore #OC-10 “White Sand”

Color System*		Coordinates	
Munsell	Hue	Value	Chroma
	2.9Y	8.3	1.4
CIE L*a*b*	Black to White	Green to Red	Blue to Yellow
	L84.05	a-0.36	b+9.95

The degraded off-white paint layer was matched by eye at 30X magnification under a color-corrected light source to the Munsell Book of standards and it was measured with a Minolta CR 241 colorimeter/microscope. The swatch for OC-10 is an excellent visual match to the best surviving areas of this original off-white exterior trim paint. The evidence in the cross-section and the uncast samples suggest this paint was originally moderately glossy and could be reproduced in a semi-gloss level coating.
