Road Safety Review

SC 700 (Maybank Highway) Charleston County, SC

May 6, 2019

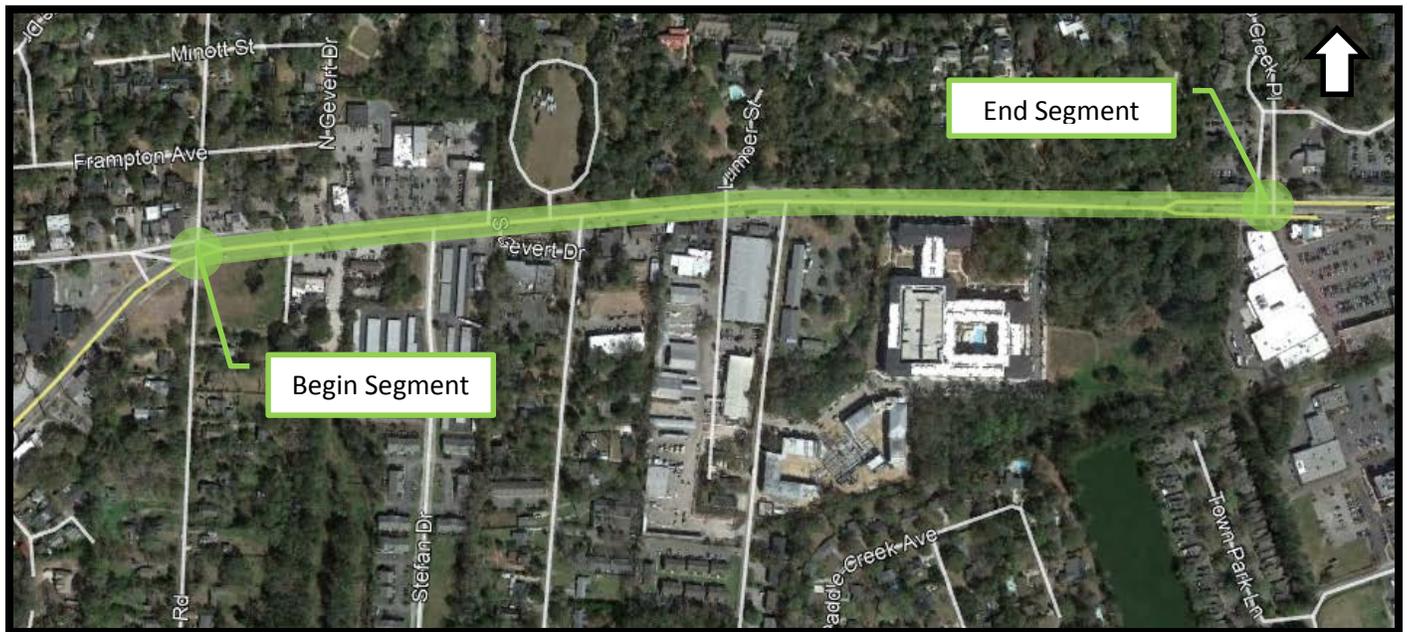
Figure 2 – Corridor Limits

The section of SC 700 (Maybank Highway) selected for the road safety review was based on the crash frequency and severity involving pedestrians and bicyclists on the corridor in recent years. The section reviewed begins at Woodland Shores Road / Wappoo Drive and continues east to Wappoo Creek Drive. The segment is approximately 0.65-mile in length. The figures below provide an overview of the corridor location.

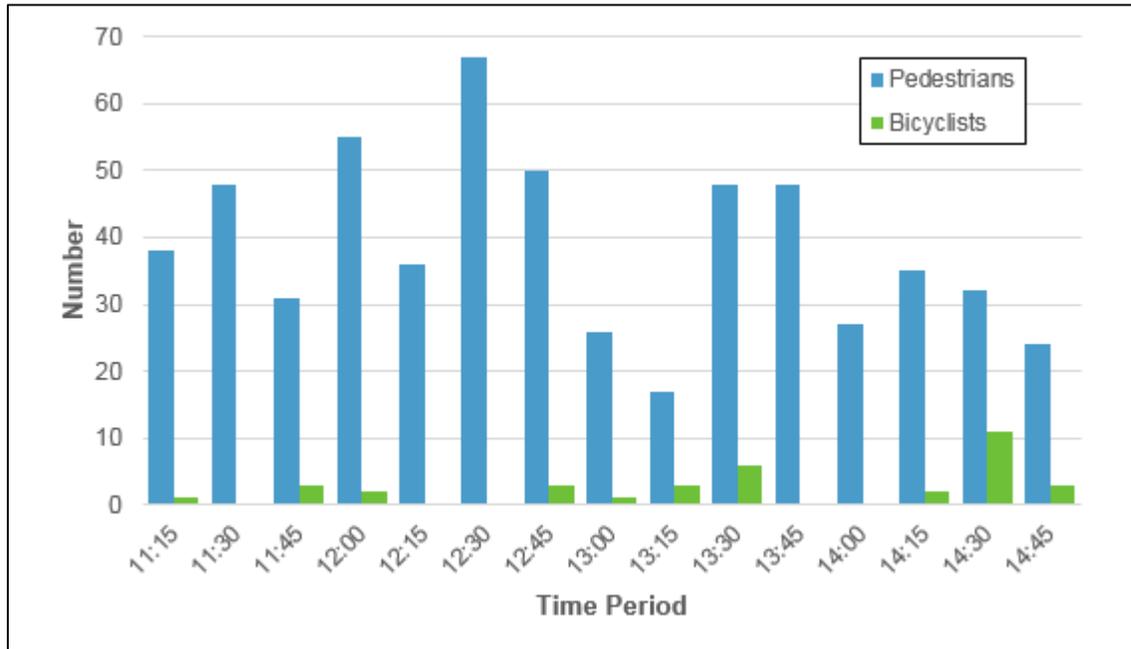
Figure 3 – Sunday, March 24 Activity, S. Gevert Dr. to Stefan Dr.

Additionally, Charleston Moves conducted bicycle and pedestrian counts on Sunday, March 24 between 11:00 a.m. and 3:00 p.m. while the local farmers' market was in operation as well as Wednesday, March 27 between 6:30 p.m. and 10:30 p.m. The data was collected at the intersection with Woodland Shores Road, on Maybank Highway between South Gevert Drive and Stefan Drive (0.1-mile segment), and at the intersection with Wappoo Creek Drive. Of these three areas, the segment of Maybank Highway between South Gevert Drive and Stefan Drive experienced the highest pedestrian and bicyclist demand, with the most activity occurring during the Sunday count. A graph showing the frequency of pedestrian and bicyclist crossings broken into 15-minute intervals is provided in Figure 3. As can be seen from the figure, several time periods experienced greater than 40 pedestrian crossings. While these crossings were scattered over a 0.1-mile segment, it may be possible to condense a large portion of these crossings to a single location with enhanced safety measures. Possible improvements are discussed in a later section of this report. The complete set of pedestrian and bicyclist data provided by Charleston Moves is included in the Appendix.

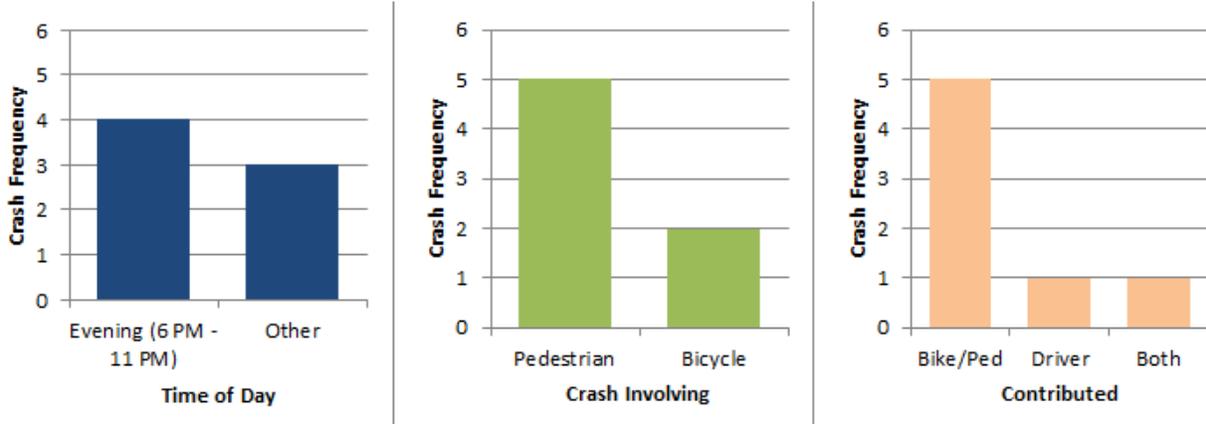
Figure 4 – Crash Statistics Summary

As seen in the above crash summary table and graph, a total of seven reported crashes occurred during the review time period. More crashes occurred during the evening hours (6 – 11 PM) than during the rest of the day. Five crashes were reported to involve pedestrians, while two involved bicyclists. Five of the crash reports listed the pedestrian or bicyclist as contributing to the crash, one listed the driver, and one listed both the bicyclist and the driver. Of the seven reported crashes, two of the pedestrian crashes resulted in a fatality. The remainder of the crashes involved minor injuries or property damage only. The figure below provides locations that the crashes occurred and their severity.

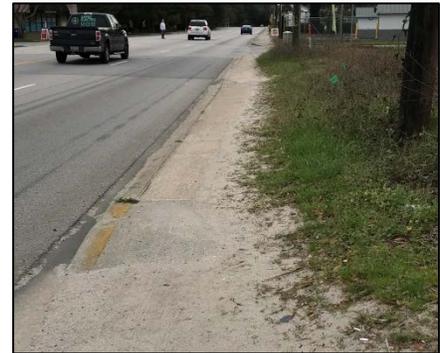
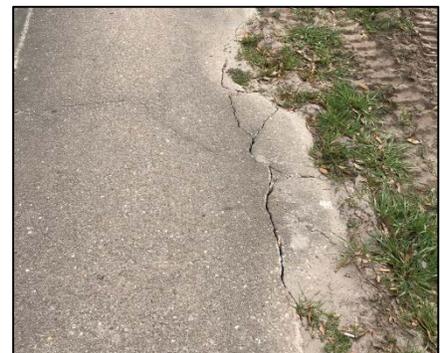
The cross-section of the corridor was discussed to determine if a change in lane widths would allow for the accommodation of designated bike lanes along Maybank Highway. However, it was determined that the existing roadway width (curb to curb) is not sufficient to provide

designated bike lanes through restriping alone. The current roadway cross section includes 15-ft outside lanes, 11-ft inside lanes, and a 12-ft two-way left-turn lane (TWLTL), for a total of 64 feet between curbs. The minimum lane width that can be considered for the corridor is 11-ft through lanes, a 12-ft TWLTL, and 5-ft bike lanes, for a total of 66 feet. Therefore, the existing roadway width cannot accommodate the minimum lane widths to install bike lanes. One alternative to achieving the necessary width to include bike lanes on the corridor is to eliminate the TWLTL by installing a raised median narrower than 12 feet with exclusive turn lanes and median breaks at key intersections. At these intersections, the roadway would require widening to provide the width for a 3-ft minimum median adjacent to the turn lane and 11-ft minimum left-turn/U-turn lane. Additionally, small U-turn bulbs may need to be provided to accommodate the design vehicle due to the raised median preventing left turns at other locations. A concept sketch of this treatment is shown in Figure 5 below. Note that the revised lane widths and bike lanes are not shown in this figure.

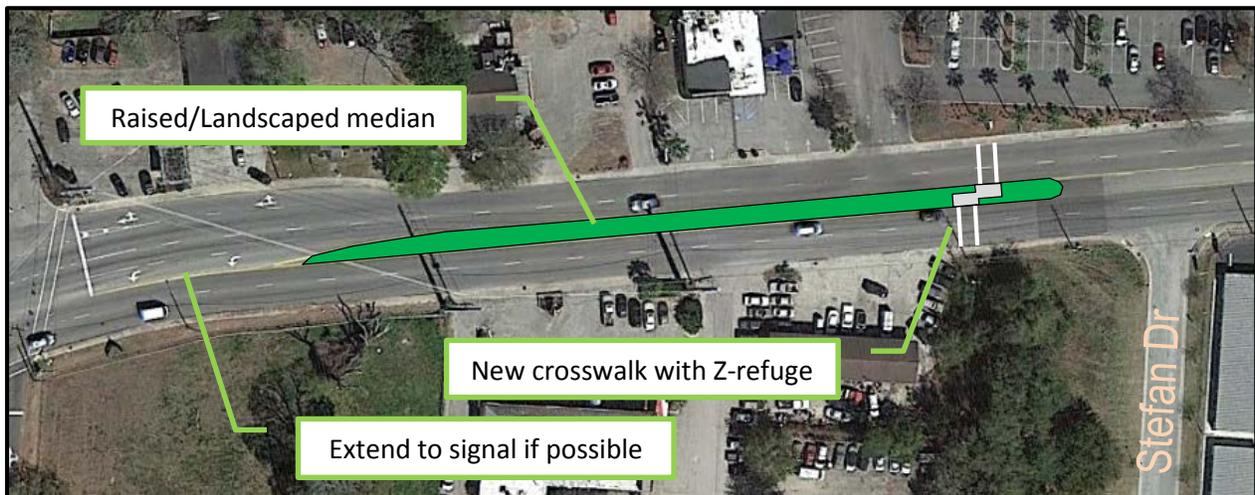
Figure 7 – Median with Pedestrian Refuge (Option A)

When considering the installation of raised medians, they must be installed such that they do not present a hazard to the driver or a false sense of security to a pedestrian waiting within the refuge. Therefore, the medians should terminate at intersections and it is preferred that they be several hundred feet long, at minimum. Shorter raised medians installed within TWLTLs will affect driver expectancy, and vehicles will tend to clip the median noses, causing a hazard to the driver. Additionally, short medians with a pedestrian refuge would not provide a sufficient distance between the pedestrian and the oncoming vehicle in the event that a vehicle strikes the median nose, therefore providing the pedestrian a greater sense of safety from oncoming traffic than actually exists. Finally, when determining the proper location for a median that will provide a pedestrian refuge, pedestrian demand should be considered. A median refuge and pedestrian crosswalk will be less utilized if it is not located within an area where the pedestrian demand is present. Two examples of possible median locations for the purpose of providing a pedestrian refuge and crosswalk are shown below.

The two options shown in the above figures are examples of median locations with a pedestrian refuge where pedestrian demand is known to exist based on field observations and the crash reports discussed earlier. Some of the advantages and disadvantages to each location are listed in the table below.

The above options are meant to be representative of possible median locations, as there may be additional options to be considered. Corridor master planning, property redevelopment, and pedestrian demand are some factors to consider when selecting a median location. In addition, when designing a median and crosswalk location, fencing may be desired within the median to encourage crossing at the marked crosswalk. Maintenance of the fencing and sight distance from adjacent driveways are factors to consider when determining the need for fencing. At a minimum, the crosswalk should include pedestrian warning signs; however, enhanced devices such as Rectangular Rapid Flashing Beacons (RRFBs) may be considered with the installation of the crosswalk. These devices require an engineering report and interim approval from the Federal

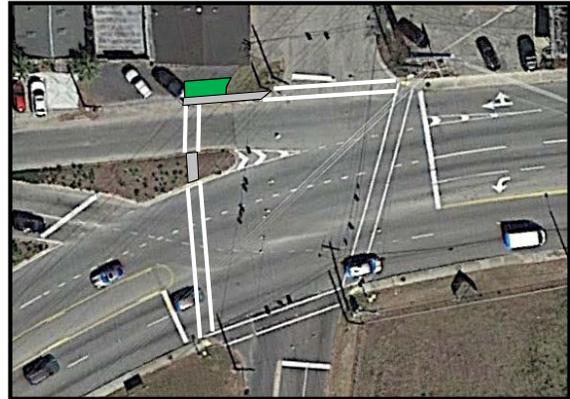
- Consider eliminating one approach to the traffic signal by installing a cul-de-sac on the north leg of Woodland Shores Road or on Wappoo Drive. This would require a traffic study and public involvement, but would reduce intersection complexity and delay for pedestrians.
- Install signalized crosswalks across the north and west legs of the intersection. This would require closure or reduction of the gravel parking for the business on the northwest corner of the intersection. A high-level concept of this improvement is shown here (right).
