Service Bulletin

SAFETY RECALL

2003-2004 GL1800/A

Frame Weld

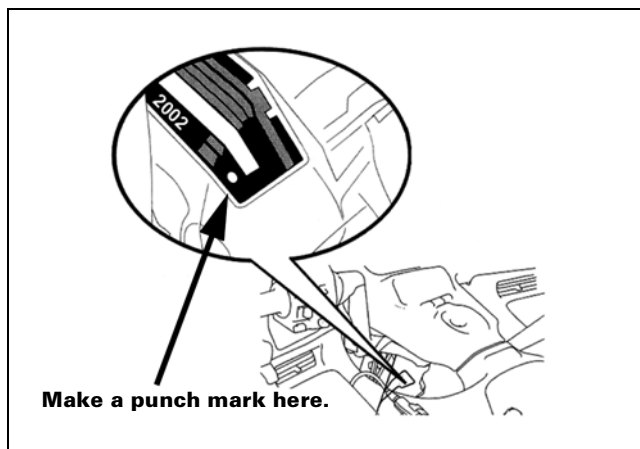
After you have completed the disassembly, welding, painting, and re-assembly procedures, make a punch mark on the lower right hand corner of the VIN plate, as shown below.

If there is a punch mark on the VIN plate as specified in this Service Bulletin, the unit has been repaired and no further action is required.
