The Bernard Property

The Bernard's property sits at the confluence of Teels Creek and a small unnamed tributary in Franklin County.

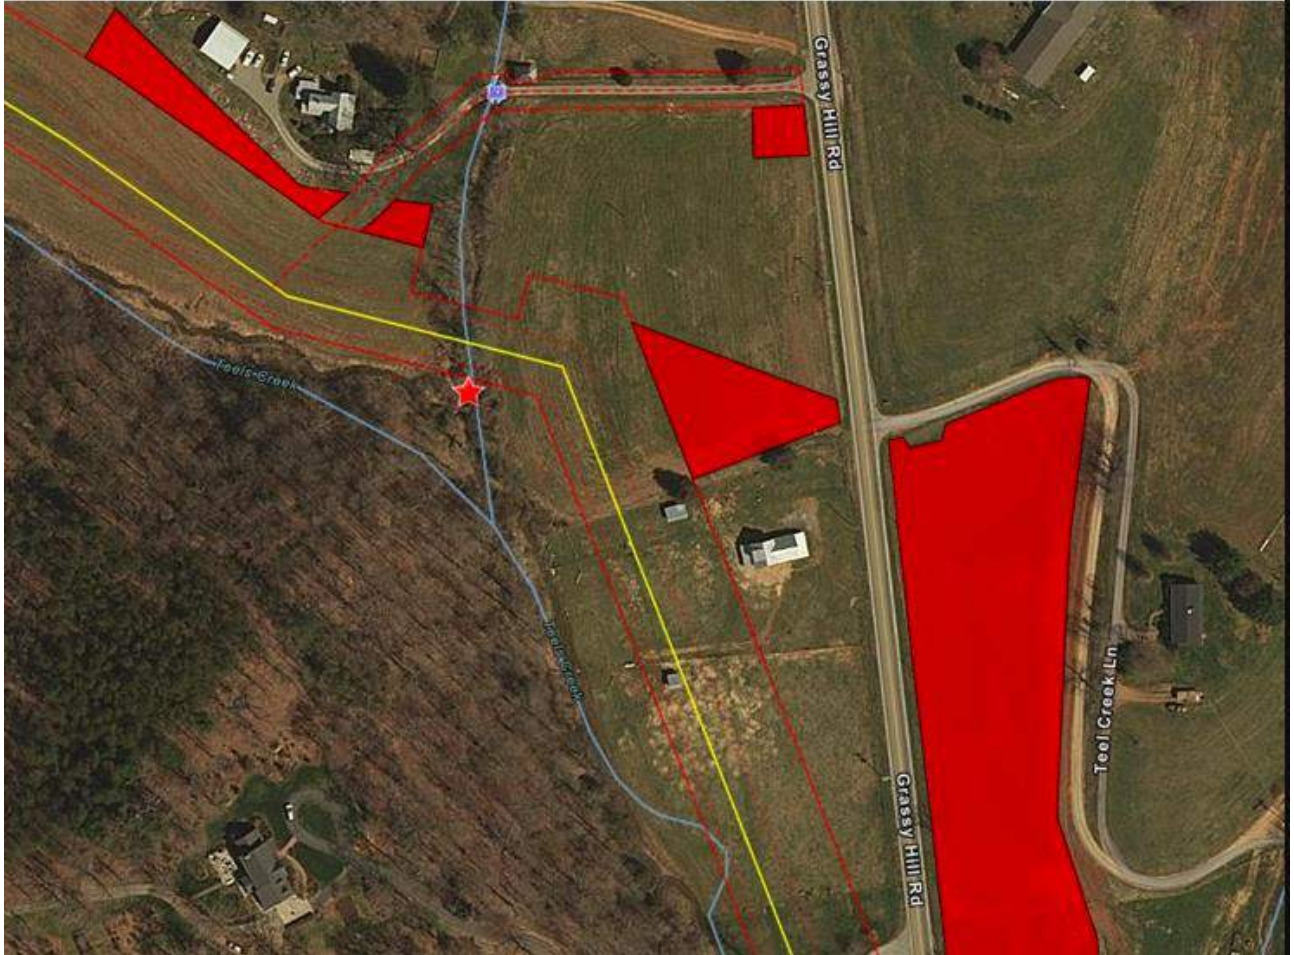
Fig. 1 – Bernard property, MVP easements in red with right-of-way between thin red lines. The star indicates the area depicted in photographs below.

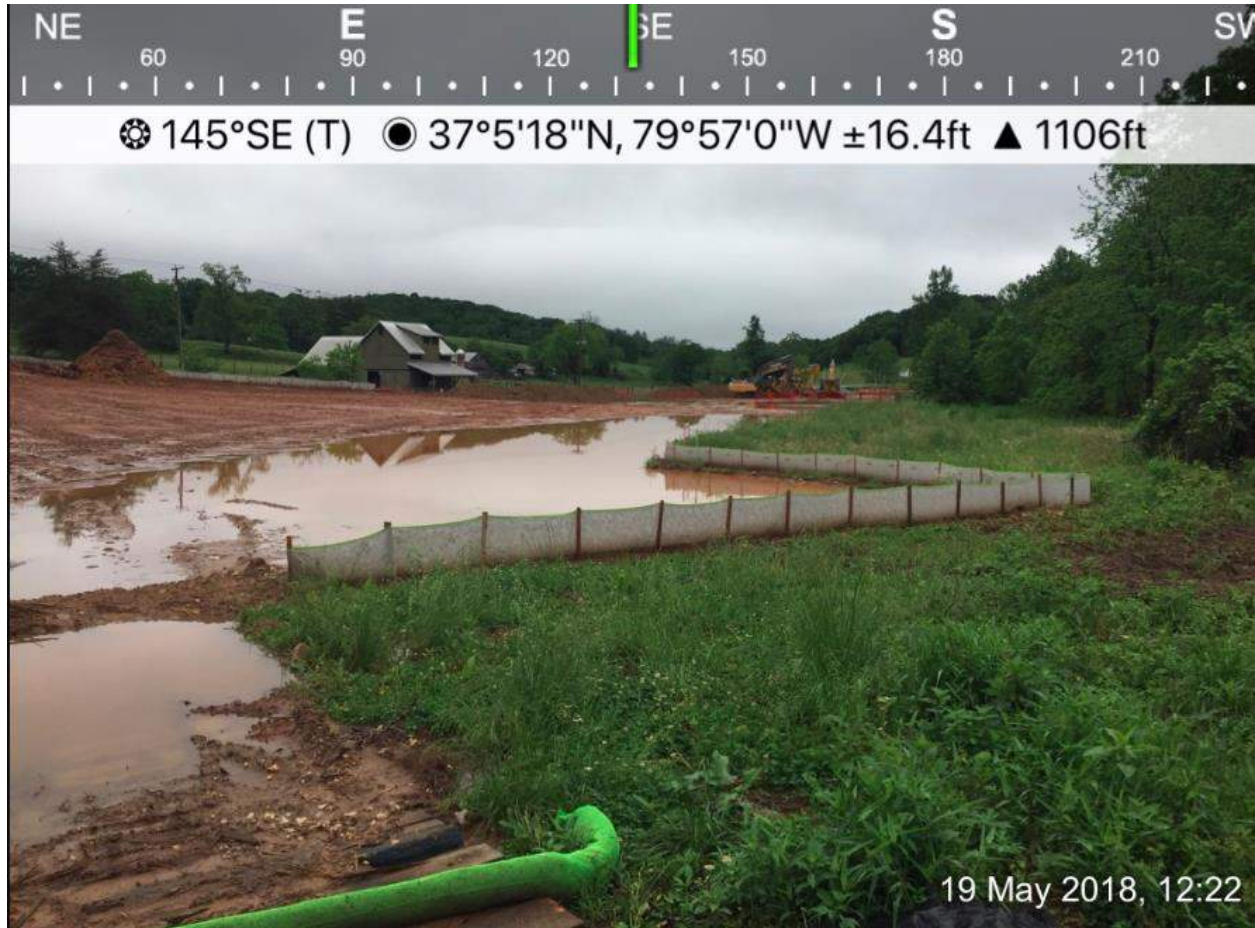
From the earliest days of active construction at this site, which lies in a marshy floodplain, the right-of-way has been filled with a ponded body of water. This water either seeps to the streams gradually or, when rains occur, is pushed in mass over, under, and through the silt fences and silt socks installed.

Fig. 2 – Bernard property, May 19, 2018

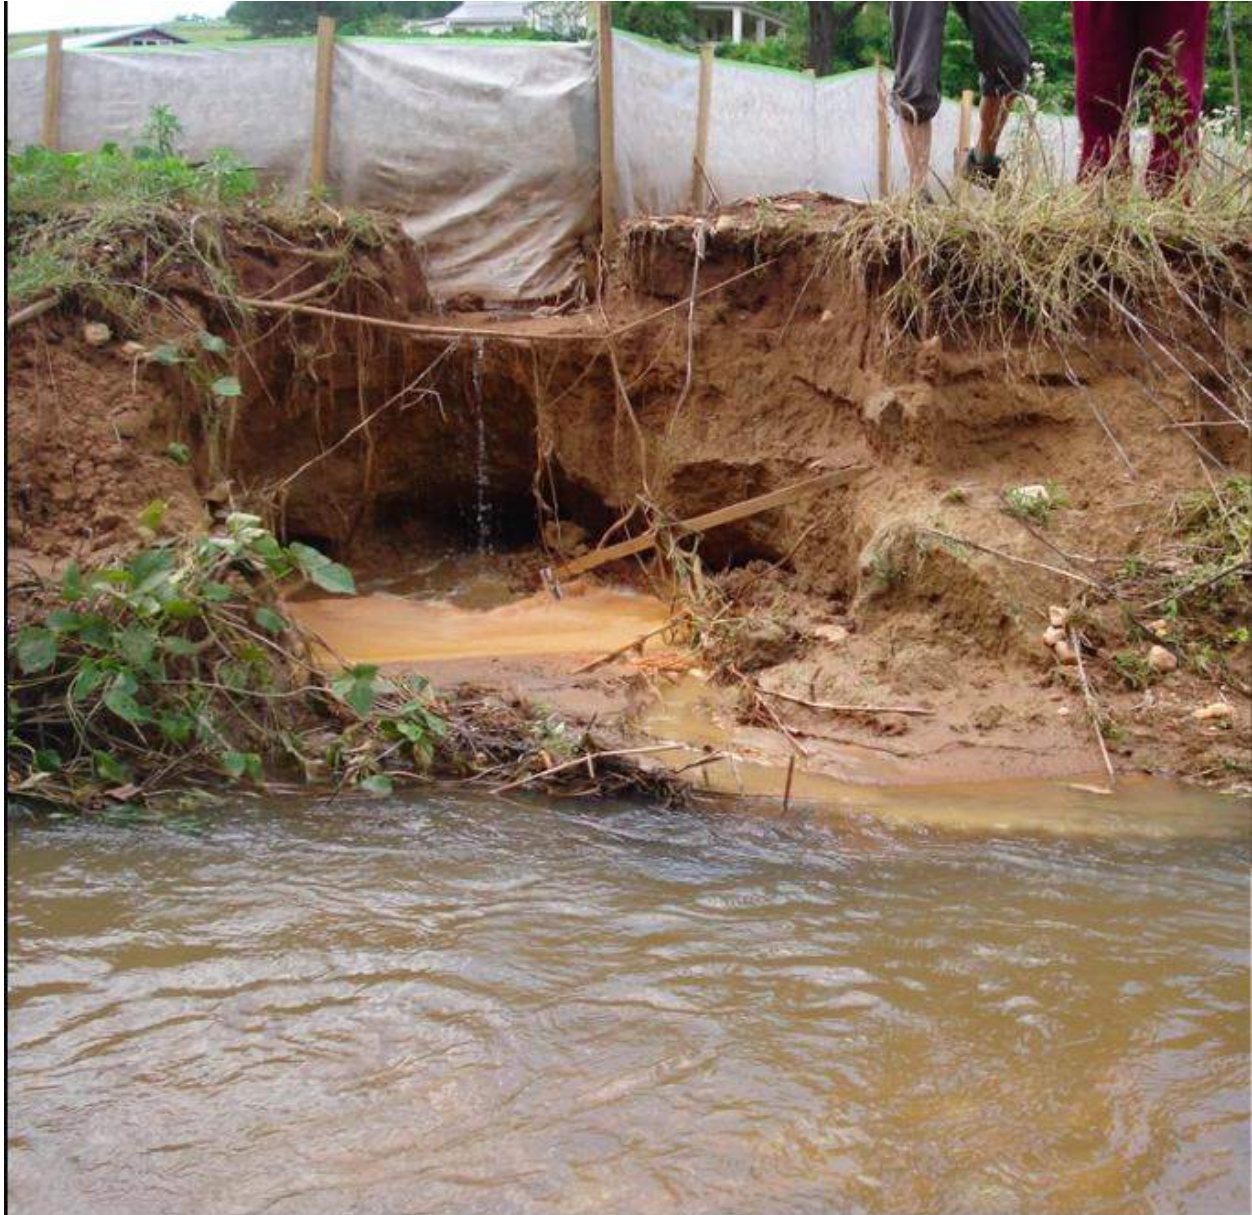
Also, from the very earliest stages of land disturbance, the erosion and sediment control measures have failed. Sediment has flowed from the site into both Teals Creek and the tributary. The flow patterns and intensity of runoff have changed because of the removal of landcover and ponding of very large volumes of water. This caused the bank shown here to collapse and other parts of the channel are continually being eaten away because of these changes and will contribute excess sediment to this stream forever, unless the banks are restored. This violates water quality standards by damaging the physical and biological integrity of the streams.

Fig. 3 – Bernard property, May 20, 2018 (looking across Teals Creek to the northeast; tributary enters Teals downstream and to the right from this spot.) This is the same location as shown in Fig. 3. New measures have been installed but very heavy sediment discharges continued in June.

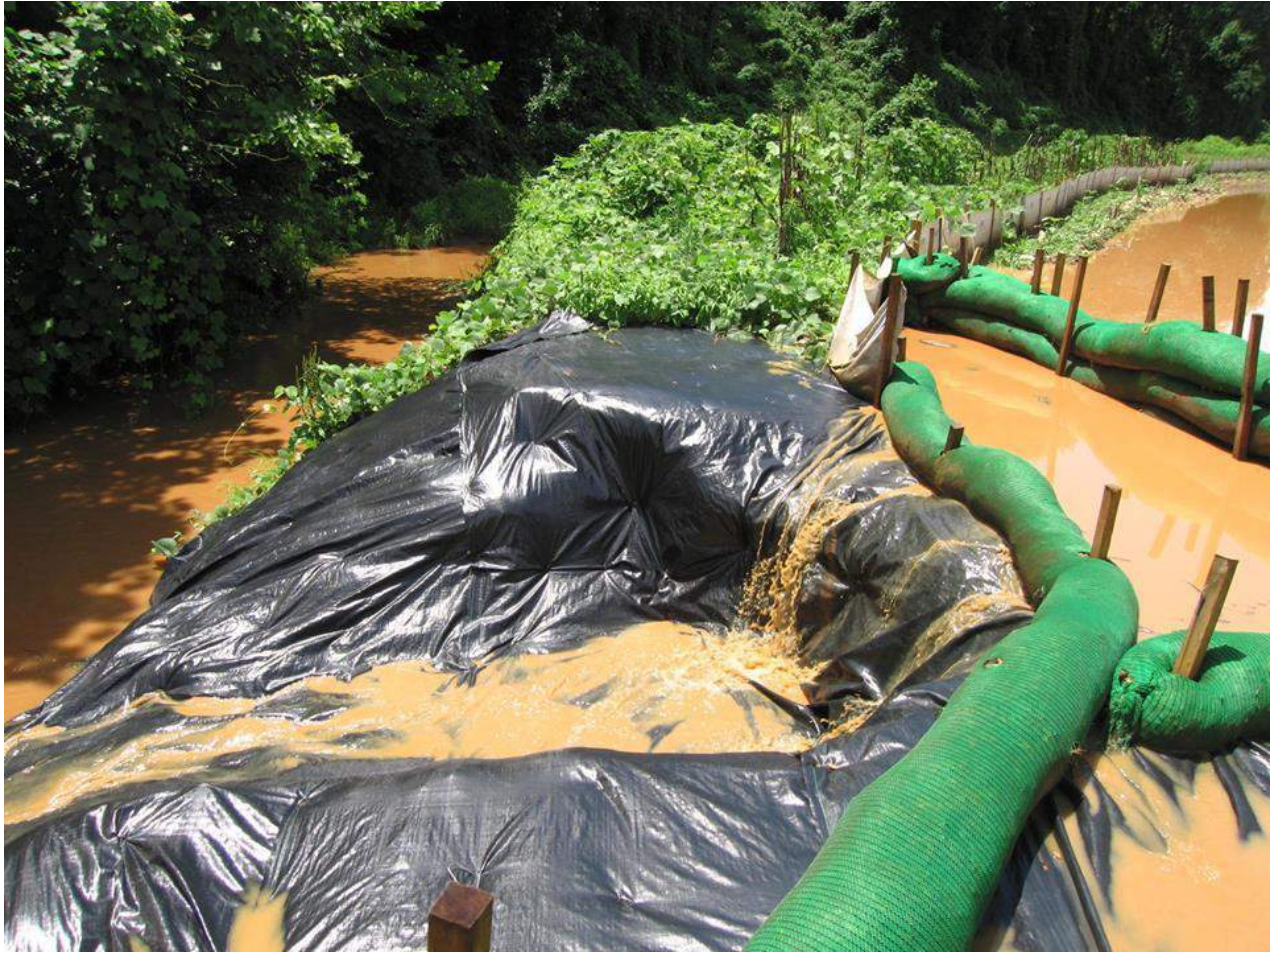
Fig. 4 – Bernard Property, June 22, 2018(same site as in Fig. 3, facing west)

This view again shows the ponded water on the right-of-way near the confluence of the two streams. The pipe was installed in the trench to this point on or about August 1, 2018 and photos show the end of the pipe floating up from the bottom almost immediately. This condition has persisted until the present.

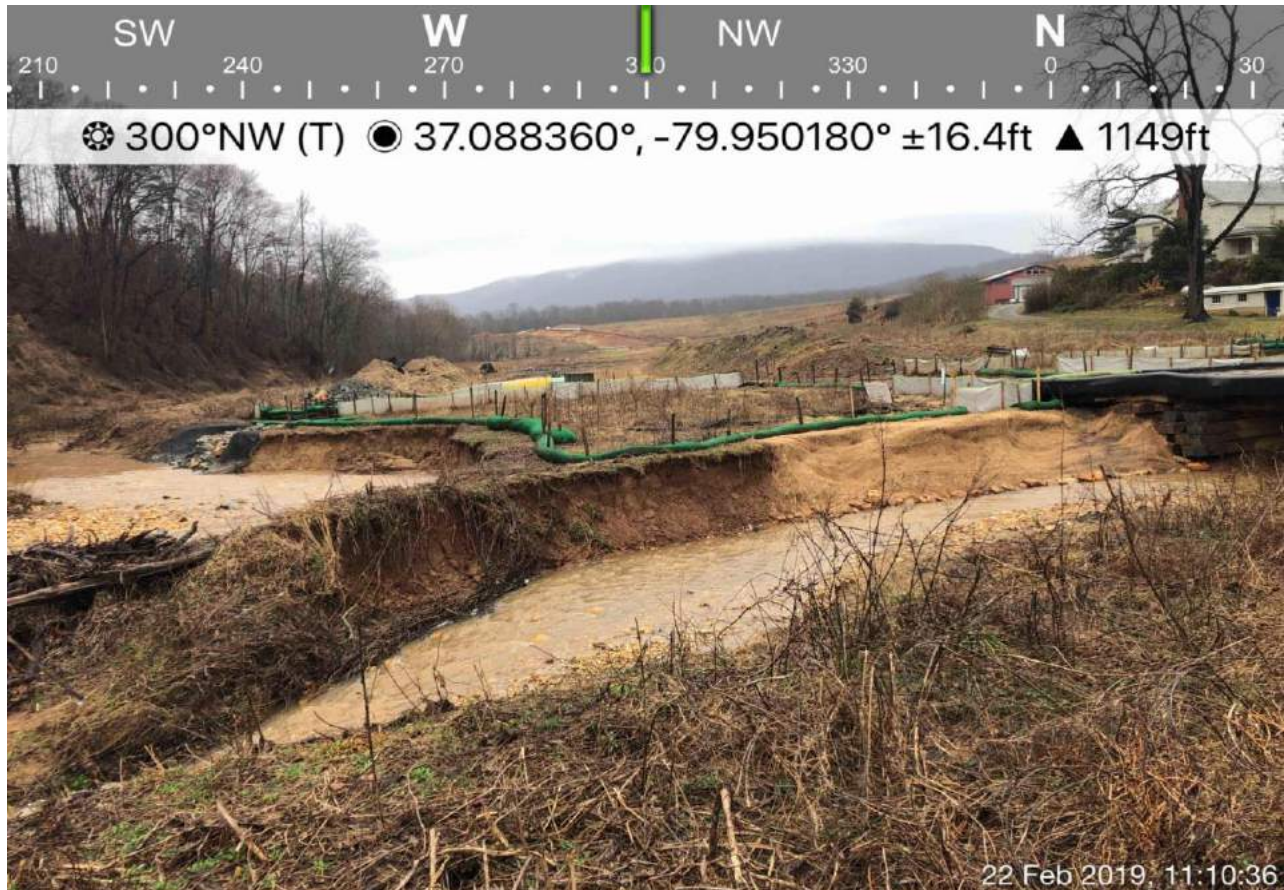
Fig. 6 – Bernard Property, February 22, 2019 (the site shown in Fig. 4 is located at the left center of the photo)
