Property Inspection Report

123 Main Street, Destin, FL 32541

11/22/2020

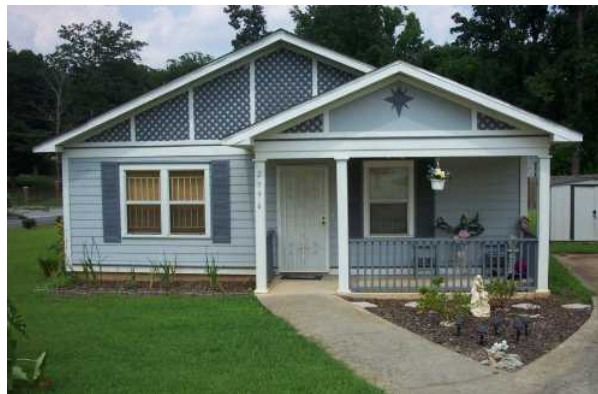
- **Monitor:** Minor settlement cracks were observed in the foundation walls. This implies that some structural movement of the building has occurred. Cracks of this type should be watched for any sign of additional movement. In the absence of any sign of ongoing movement, repair should not be necessary

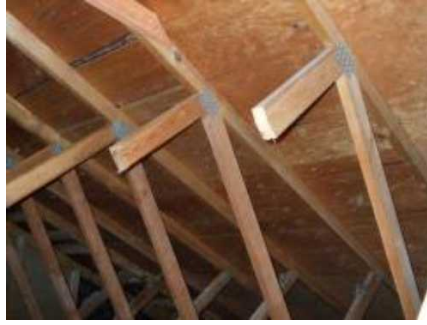
- **Repair:** Truss members should not be cut, notched, drilled, spliced or otherwise altered in any way without the approval of a registered design professional. This condition should be evaluated by a qualified engineer.

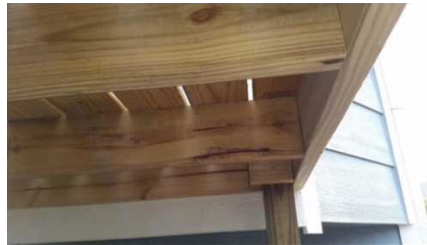
- **Safety issue:** The floor joists on the deck are toenailed to the ledger board which compromises the integrity of the deck. Joist hangers or an equivalent system are necessary to support the joists and prevent potential deck failure.

- **Safety issue:** The floor joists on the deck are toenailed to the ledger board which compromises the integrity of the deck. Joist hangers or an equivalent system are necessary to support the joists and prevent potential deck failure.

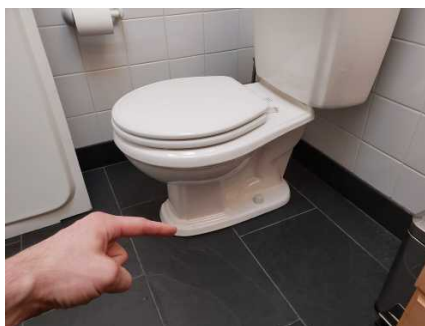
- **Repair:** The toilet is loose as noted in the Hall bath. Have the toilet properly bolted to the floor.
