Possible Electrical Transformer Defect

Technical Bulletin Reference No. 2110-001

Delta III Metal Bonnet Update

Technical Bulletin Reference No. 2110-002

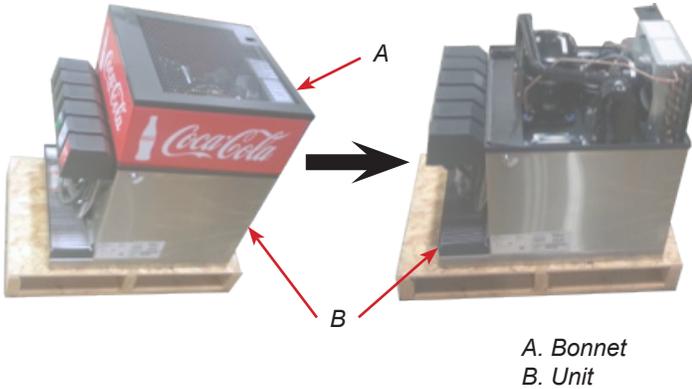
1. Check the current status of the unit: If the unit is still in its packaging, cut bands using a knife/cutter and lift top portion of carton then remove top inner carton pad and corners. If unit is in use, unplug from power.
2. Remove the bonnet from the unit by lifting up.

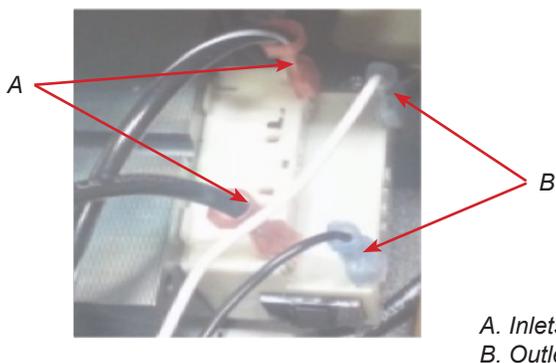
4. Using pliers, disconnect the four (4) faston cables from the transformer.

The two (2) thick cables on the left (black with white ribbon and black) are the inlets. The two (2) thin cables on the right (white and black) are the outlets.

Be careful not to pull from the cable but from the terminal so to avoid damaging the cable to terminal connection.

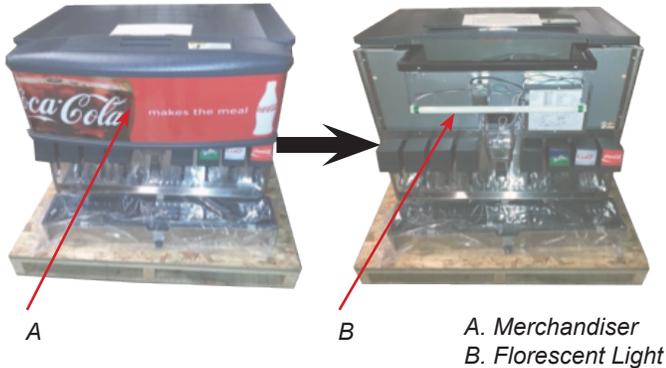
1. Check the current status of the unit: If the unit is still in its packaging, cut bands using a knife/cutter and lift top portion of carton then remove top inner carton pad and corners. If unit is in use, unplug from power.
2. Remove the merchandiser from unit by lifting and pulling out.

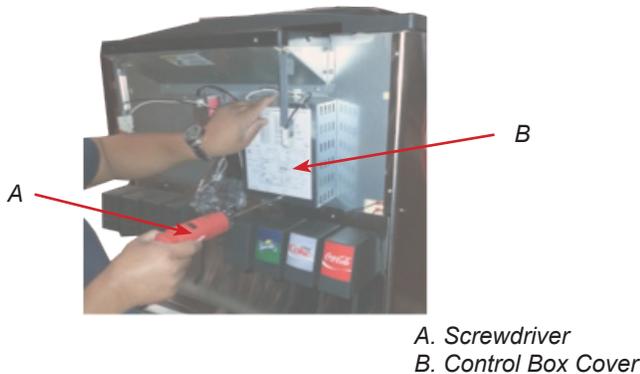
3. Remove florescent light bulb by turning and pulling out.
4. Using a screwdriver, remove the control box cover by removing the two (2) screws on front of the control box.

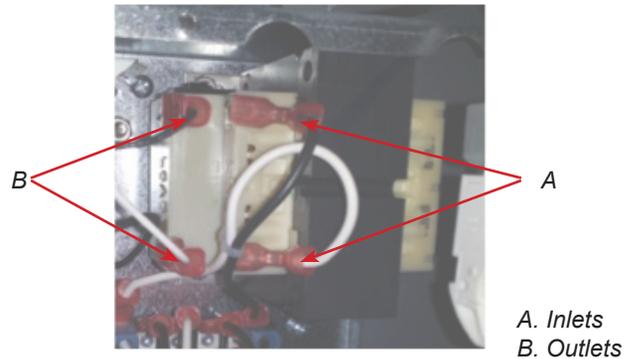
6. Using pliers, disconnect the four (4) faston cables from the transformer.

The two (2) thick cables on the left (black with white ribbon and black) are the inlets. The two (2) thin cables on the right (white and black) are the outlets.

Be careful not to pull from the cable but from the terminal so to avoid damaging the cable to terminal connection.
