Digital Asset Integrity Monitoring Program Yields >\$4M Win with Asset Life Extension in SRU

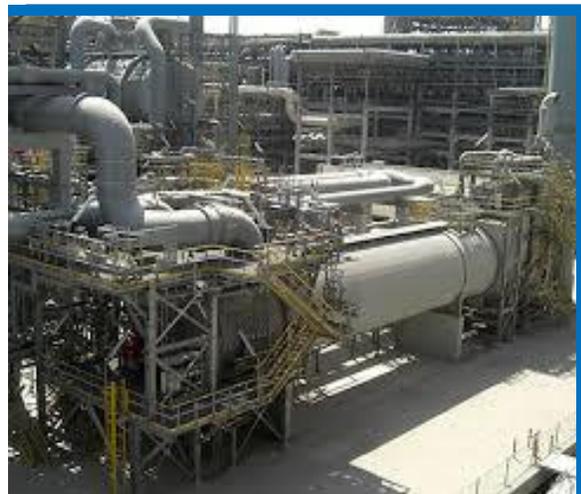
Figure 1: SRU & Tail Gas

During the Amine Treating process, the “sour” gas (H₂S or CO “rich”) counter flows the clean (“lean”) amine liquid and absorbs the gases. In this continuous cycle, corrosion may occur due to high Heat Stable Amine Salts (HSAS) that will form over time. In addition to this mechanical erosion damage, other areas may “flash” gases due to pressure drops and cause severe highly localized piping wall loss. As suggested in industry Recommended Practice API 571, HSAS above 2 wt.% may cause corrosion high rates and depending on velocity, this may occur at lower concentrations and higher flow rates. H₂S is corrosive because they lower the pH, increase solution conductivity, and can destabilize the protective sulfide layer (film) in equipment/piping. HSAS, in high flow or coupled with areas of high turbulence/changes in flow also cause tremendous, localized wall loss erosion-corrosion. In this case, it was determined that the design of a nozzle in the horizontal position of the exchanger is a bad industry design and causes turbulence (eddy’s) that increase the corrosion rate in specific areas.
