REPORT #E20-399

# Commercial Window Attachments: Secondary Window Market Characterization

# University of Oregon Straub Hall

## Secondary Window Attachment Case Study

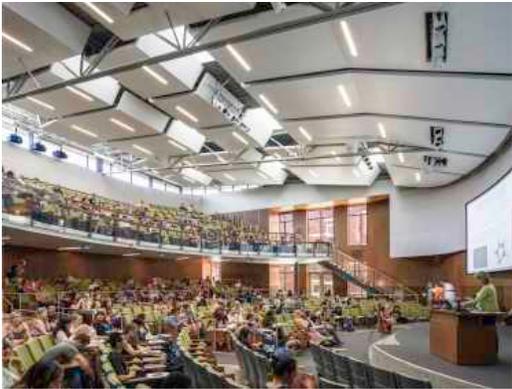
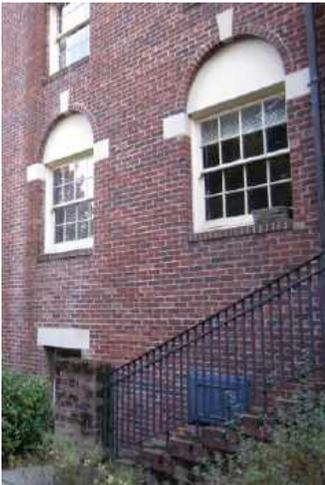
Original windows

The original windows in Straub Hall were single-pane, double-hung windows. The window panes themselves were in an excellent condition and had wooden frames, which were also in a good condition. However, many of the windows in Straub Hall had become inoperable over time. As a result, many building occupants were unable to open their windows.

Additionally, the original windows were not weather-stripped, so many spaces in Straub Hall were drafty, particularly in the winter. Before the 2014 renovation, occupants stated that although sections of the building had felt warm (due to fireplaces within the building), sections of the building near the windows felt chilly.

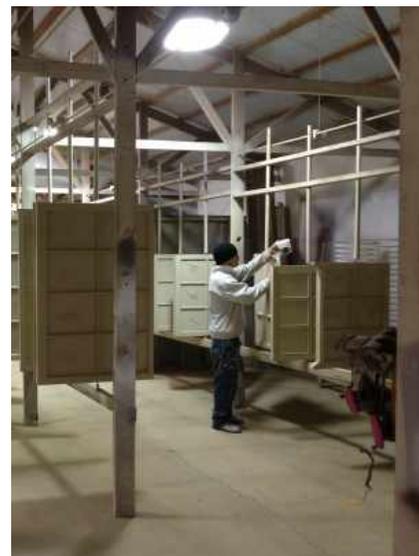
Chosen Windows restoring Straub Hall window sashes in shop

- 1. Before Installation:** Chosen Windows removed the existing window sashes and took them back to their Portland shop. Because the windows renovation was part of a larger renovation, it was easier for Chosen to take the window sashes back to their shop rather than work around the other subcontractors on the renovation. At the shop, the original window sashes were stripped down, and the SLIP attachments were installed.

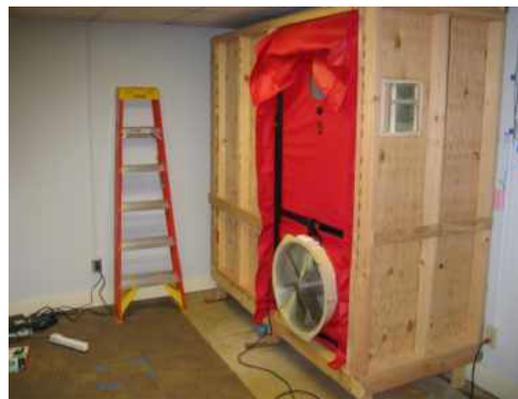
UO Energy Lab testing windows in Straub Hall

The University of Oregon hired the on-campus Energy Studies in Buildings laboratory to test the effectiveness of the following scenarios: the original windows, windows with one layer of insulated film, insulated glass conversions, and Chosen Windows's SLIP attachments. Analyses from the UO energy lab confirmed the following:

1. Even one layer of insulated film provided significantly better insulation than the original windows.
2. The insulated glass conversion option and the SLIP attachments provided nearly identical levels of insulation.

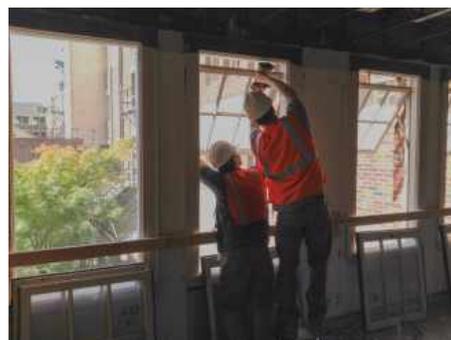
An example of a window re-installation

- 3. Installation:** After re-balancing the weight system and coordinating with other subcontractors on the project (e.g., the insulation subcontractor), Chosen Windows installed the new windows. Each window took approximately 2 to 4 hours to install (also accounting for the time it took to rebalance the weights), and the installation generally went very smoothly. However, Chosen Windows stated that a few window attachments had to be removed and reinstalled, as other subcontractors would occasionally accidentally scratch the windows.

The architects on the project performed quality assurance checks, which included a visual inspection of the windows and a spray test, which involves spraying the glass with a controlled stream of water to make sure that there were no leaks on the inside. The re-installed windows passed both tests.

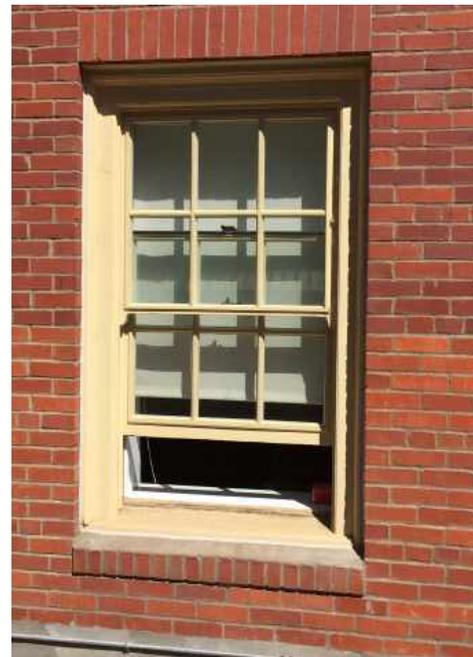
Window with SLIP attachment added
