CASE STUDY

Southeastern U.S.

Mine Closure

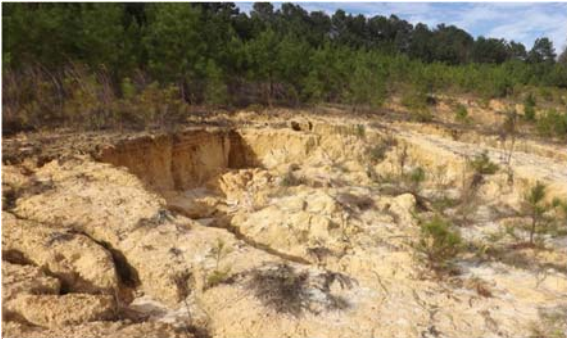
Large gullies formed due to erosion

For 13 years, an abandoned mine in the Southeastern U.S. sat partially barren. A large mining company worked to revegetate 5 acres (2 hectares) of the sprawling site several times over the years with traditional standard seeding. Every time the site saw significant rain, their seed and soil washed away. Profile® met with the project consultant for a Lunch & Learn and later stepped in to assist with the problematic site.

Following The 5 Fundamentals™ to Establishing Sustainable Vegetation, Profile first conducted a soil test that showed the substrate had a very low pH along with minimal organic matter. The problematic soil and insufficient erosion protection were the likely culprits for the previously unsuccessful revegetation attempts. Armed with this knowledge, Profile prescribed an amendment plan designed to drastically improve soil health, beginning with ProGanics™ Biotic Soil Media™. Once the amelioration plan finalized, regional seed and plant experts developed a blend of plant species that would thrive on this particular site. Finally, Profile recommended utilizing Flexterra® High Performance-Flexible Growth Medium™ to enhance vegetation establishment and prevent erosion.

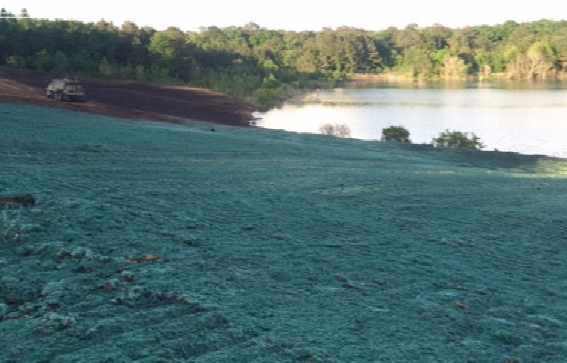
ProGanics and Flexterra applied to soil in April

- Soil tests to assess the site's agronomic value
- Slope redesign to include a terrace and cat tracking to reduce overland flow
- ProGanics™ BSM™ applied at 4,500 lb/ac (5,040 kg/ha)
- Flexterra® HP-FGM™ applied at 3,500 lb/ac (3,920 kg/ha)
- NeutraLime™ applied at 160 lb/ac (179 kg/ha) to raise soil pH
- JumpStart™ fast acting biostimulant applied at 5 gal/ac (47 L/ha)
- BioPrime™ slow release biostimulant applied at 160 lb/ac (179 kg/ha)

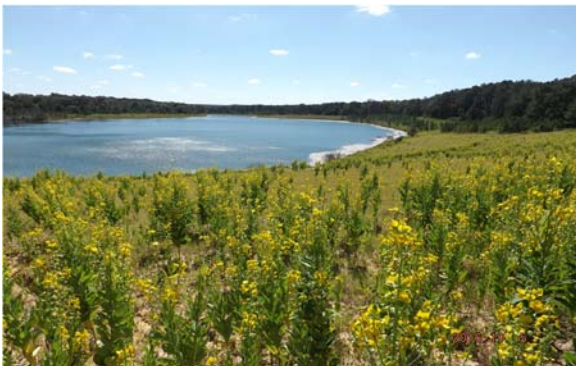
Sustainable vegetation one year later

After using the redesigned slope specifications developed in partnership with Profile and the resident engineer, a local contractor applied Profile's prescriptive solution on the site. In just a few weeks, the one-two punch of ProGanics and Flexterra succeeded in germinating the seed and establishing dense, sustainable vegetation that could stand up to adverse conditions. Not long after application, tropical storm Colin dumped 6 inches (150 mm) of rain onto the mine. The project consultant worried the slope had completely eroded. When he returned, he was amazed to find the Flexterra held the soil in place.

During follow up inspections a year later, Profile technical experts confirmed that soil health had dramatically improved:

- A five-fold increase in organic matter from 0.4 percent to 2.0 percent
- 271 percent increase in soil respiration
- 345 percent increase in bacterial counts
- 142 percent increase in fungal counts
