Map ID: 006_

Historic Name: Russell Ranch, Hall Ranch House Current Name: 808 Ranch

Location: 16750 SH 29

City: Liberty Hill State: TX County: Williamson

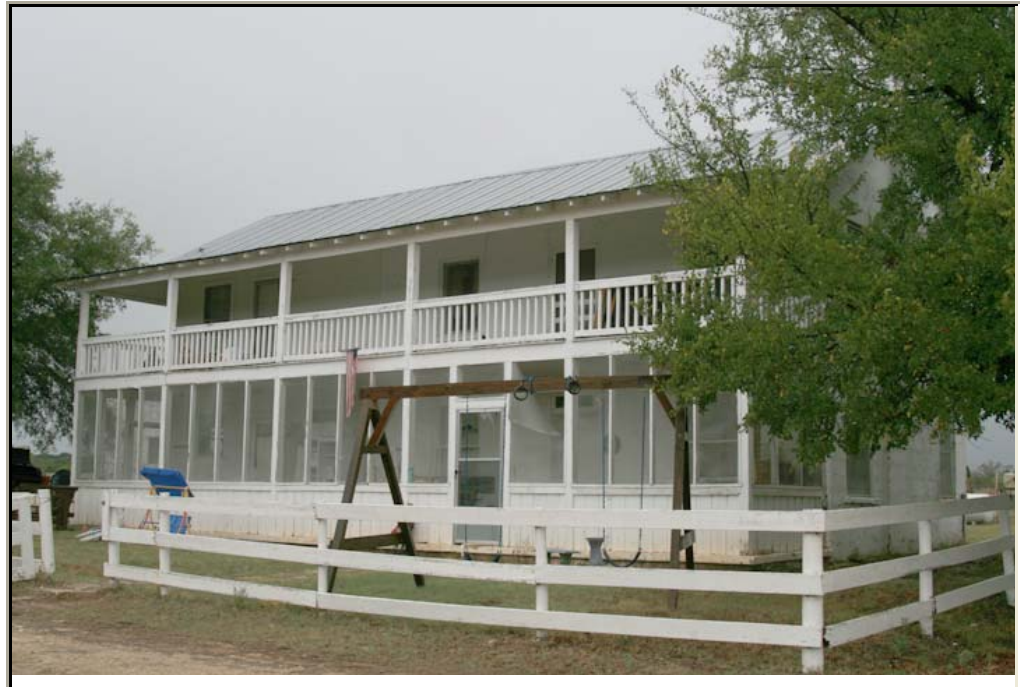
View of front of main house, view facing west.

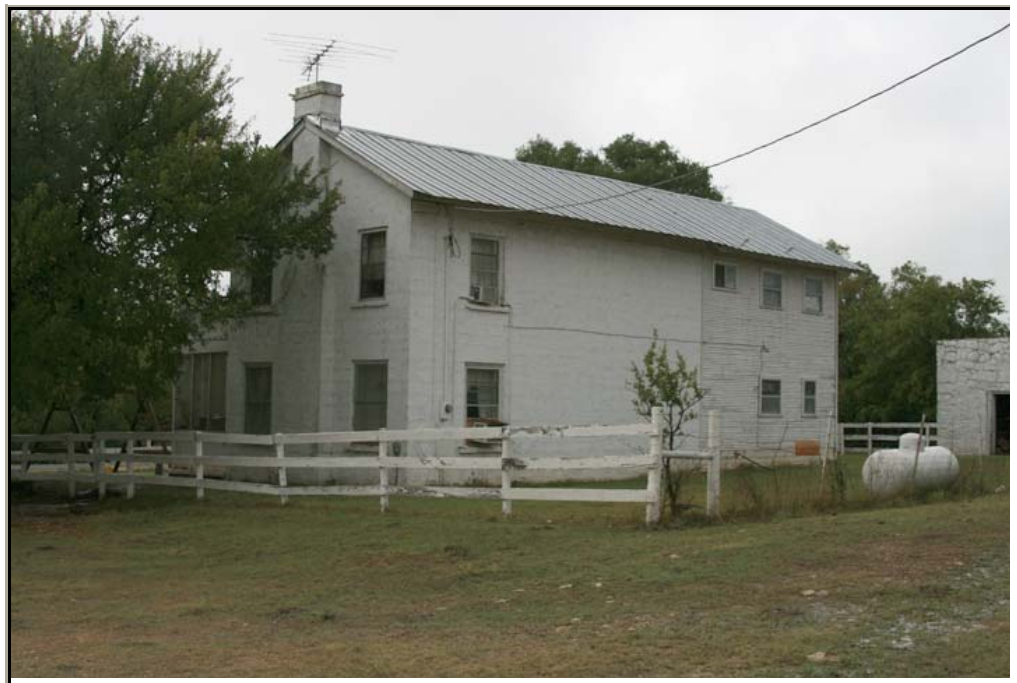
*Rear view of main house,
view facing south.*

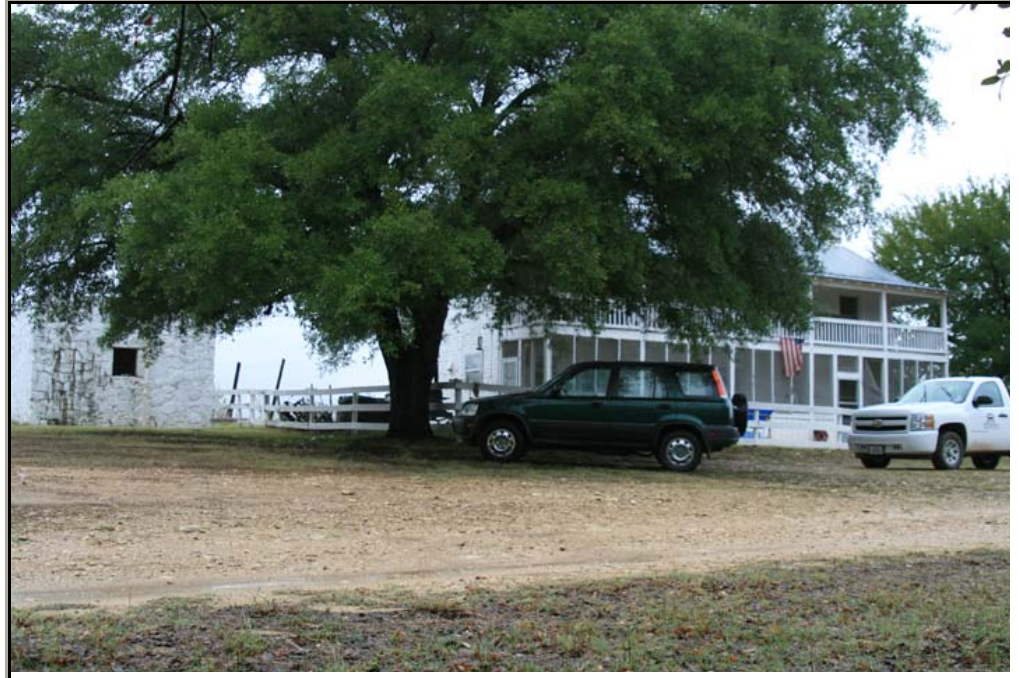
Immediately to the west of the house is a round stone cistern with a stone lid and a stone pump house. The pump house has a square plan, a centrally located door on the east side, and single window openings on the south and north sides. The roof is supported by concrete joists and cedar posts. There is a metal skeletal structure south of the pump house – the last remaining vestiges of the windmill.

View of main house and pump house (left), view facing north.

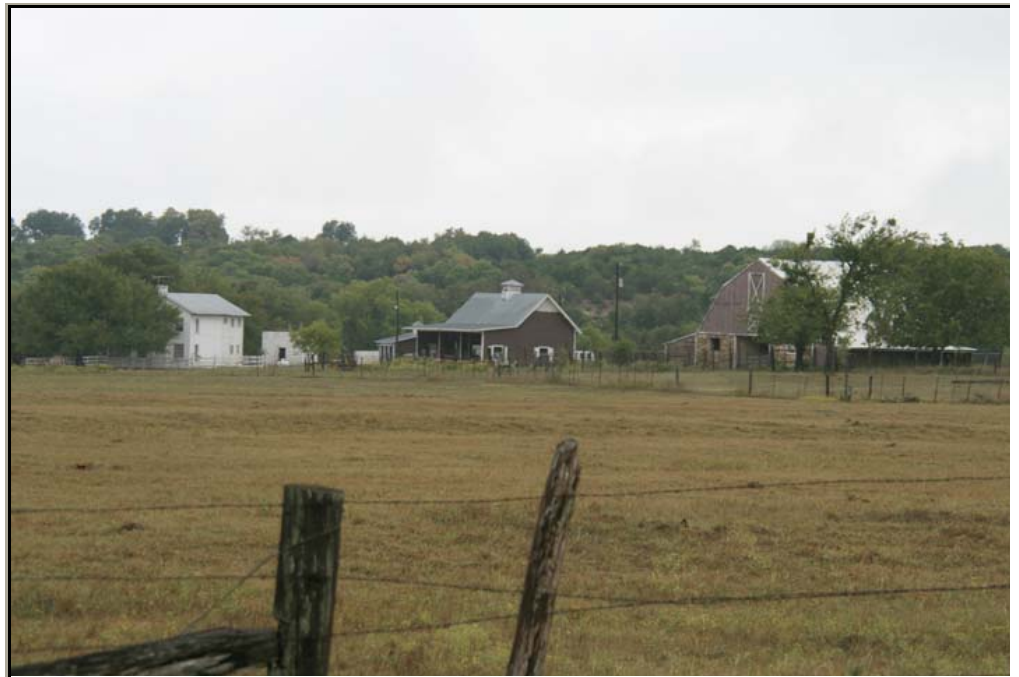
Context view from driveway of main house with pump house (left), sheds (center), and barn (right), view facing southwest.

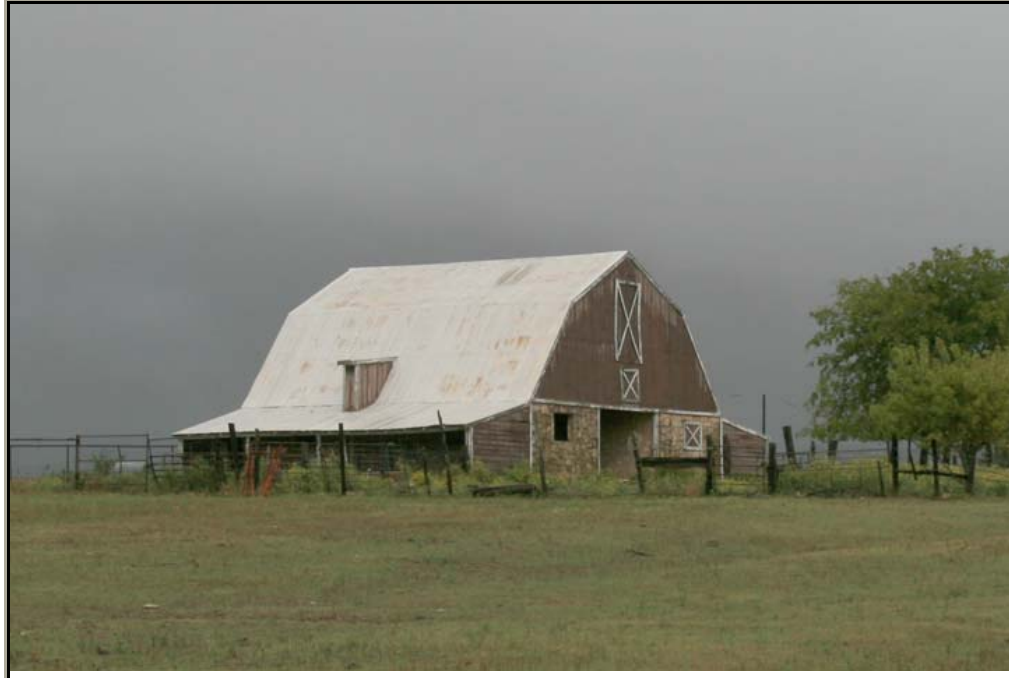
Further to the north is a ca. 1930 wood and stone barn with a gambrel roof. It has a double pen with central passage plan. The pens are made of local stone with cement-based mortar. The upper level has wood framing and the second floor joists are strengthened with cross bracing. The roof has two slender shed-roofed dormers (one on either longitudinal side) that allow hay to be tossed down from the loft to the exterior corral areas. The corral areas are protected by flush wood siding and shed-roofed metal roofs. The gambrel roof gables are covered in metal as is the roof.

View of barn, view facing northwest.

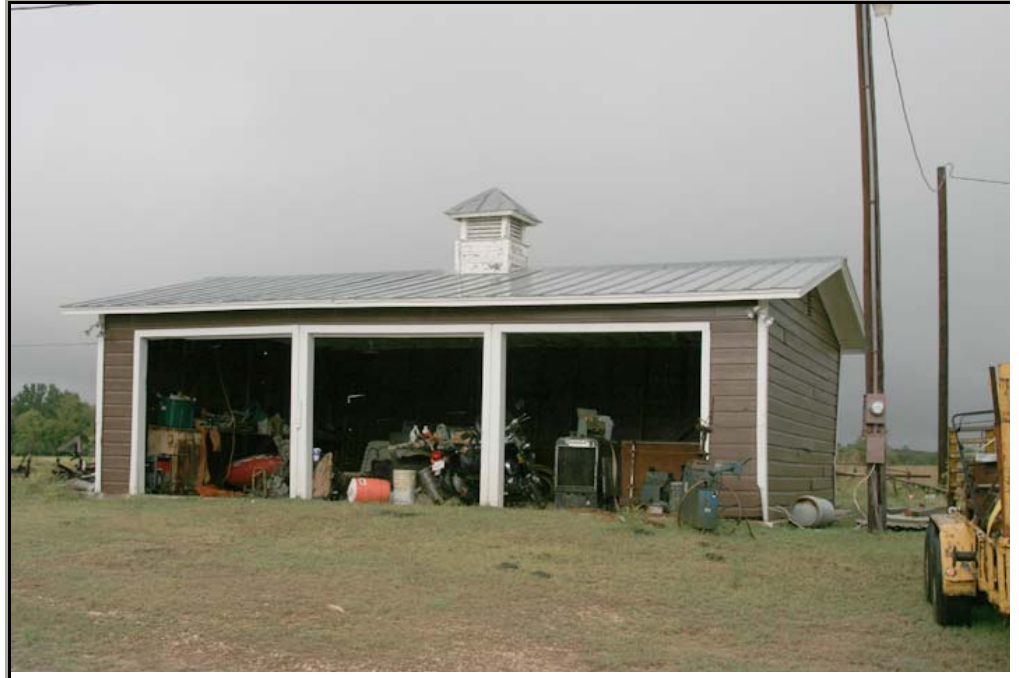
North of the house is an equipment shed on a concrete slab. The ca. 1940 shed has triple garage door-sized openings on the southeast side. It has a side-gabled wood-framed roof covered in standing seam metal with a wood ridgeline ventilator. The siding is painted flush wood.

*View of equipment shed,
view facing west.*

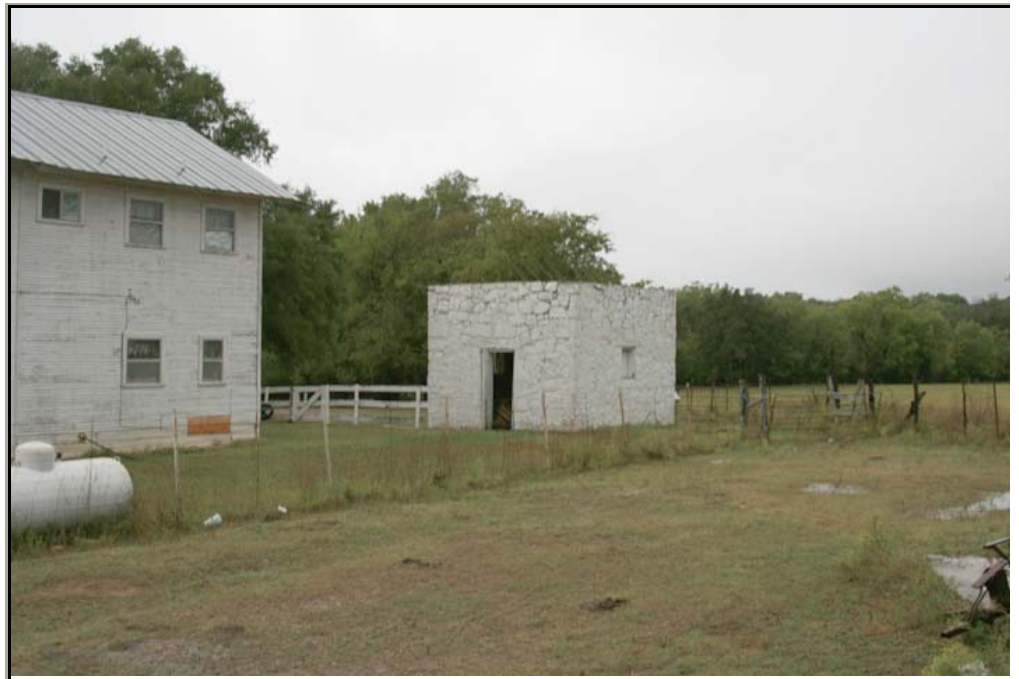
*View of pump house in
relation to main house, view
facing south.*

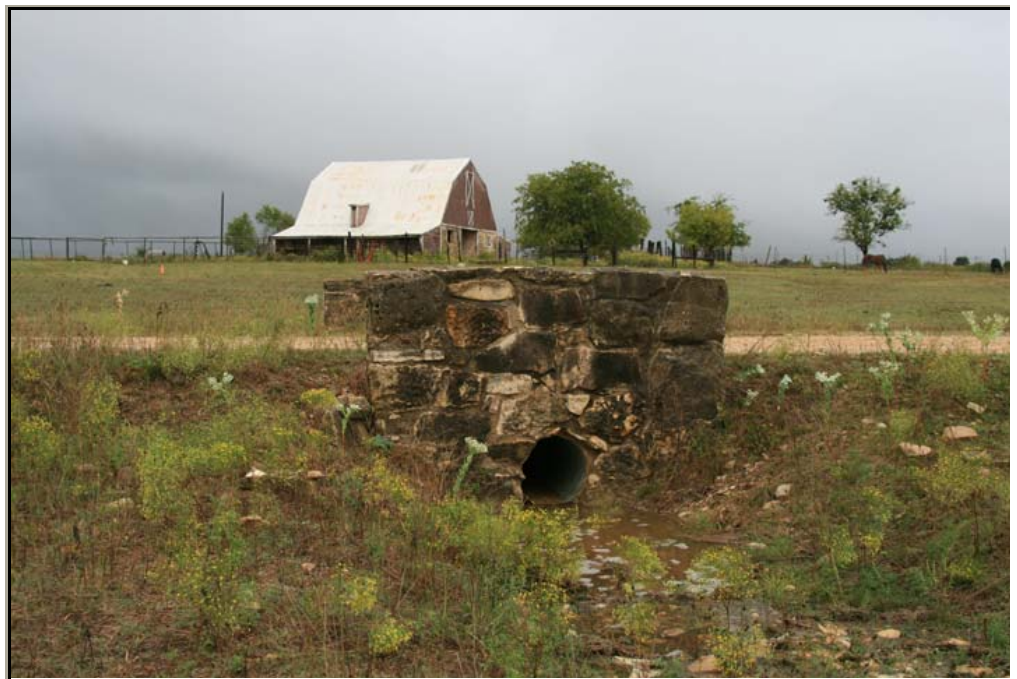
*View of stone culvert along
main driveway with barn in
background, view facing
northwest.*
